**PHASE I ENVIRONMENTAL SITE ASSESSMENT
PORTION OF SE17-39-01 W5M
LACOMBE COUNTY, ALBERTA**

April 2008

EE-24888

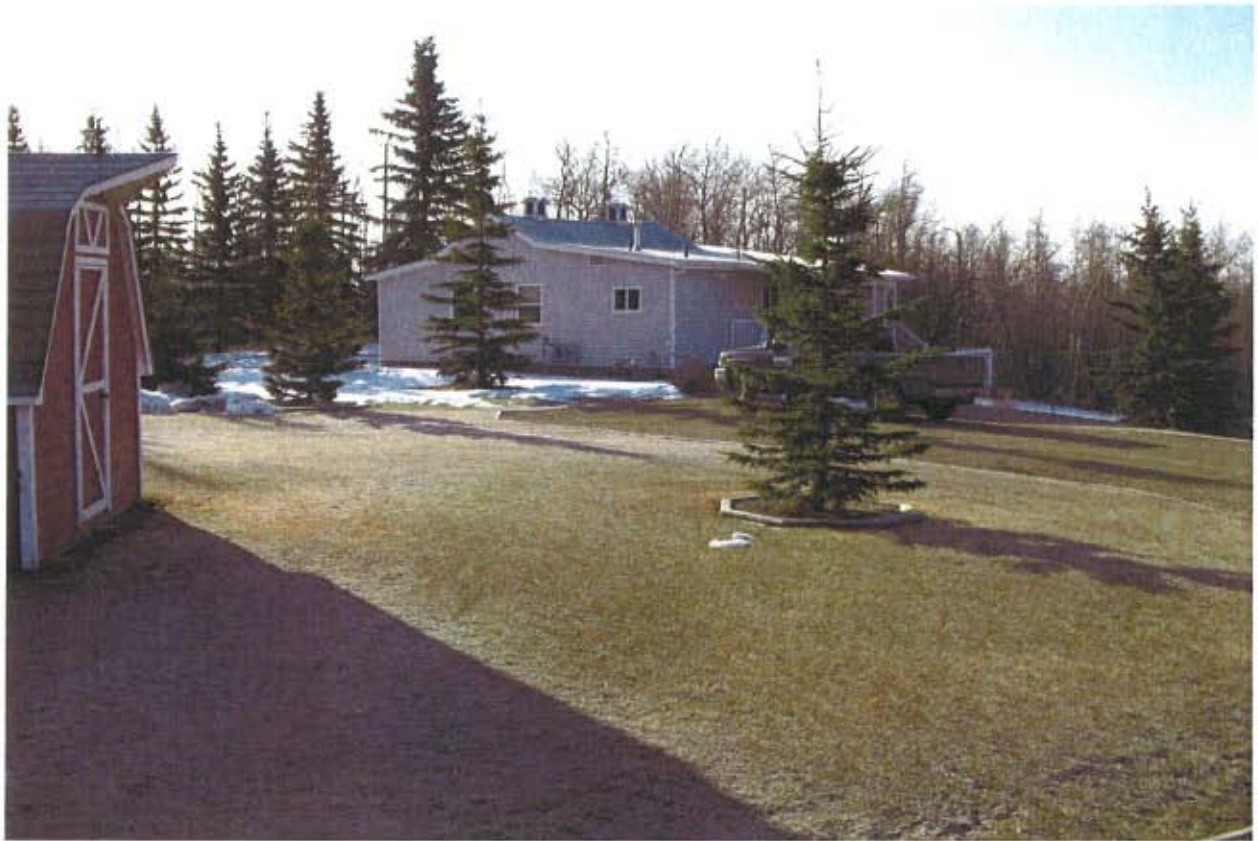
Plate 1: The house as viewed from the northwest. One of the many sheds on the Site is visible to the left.

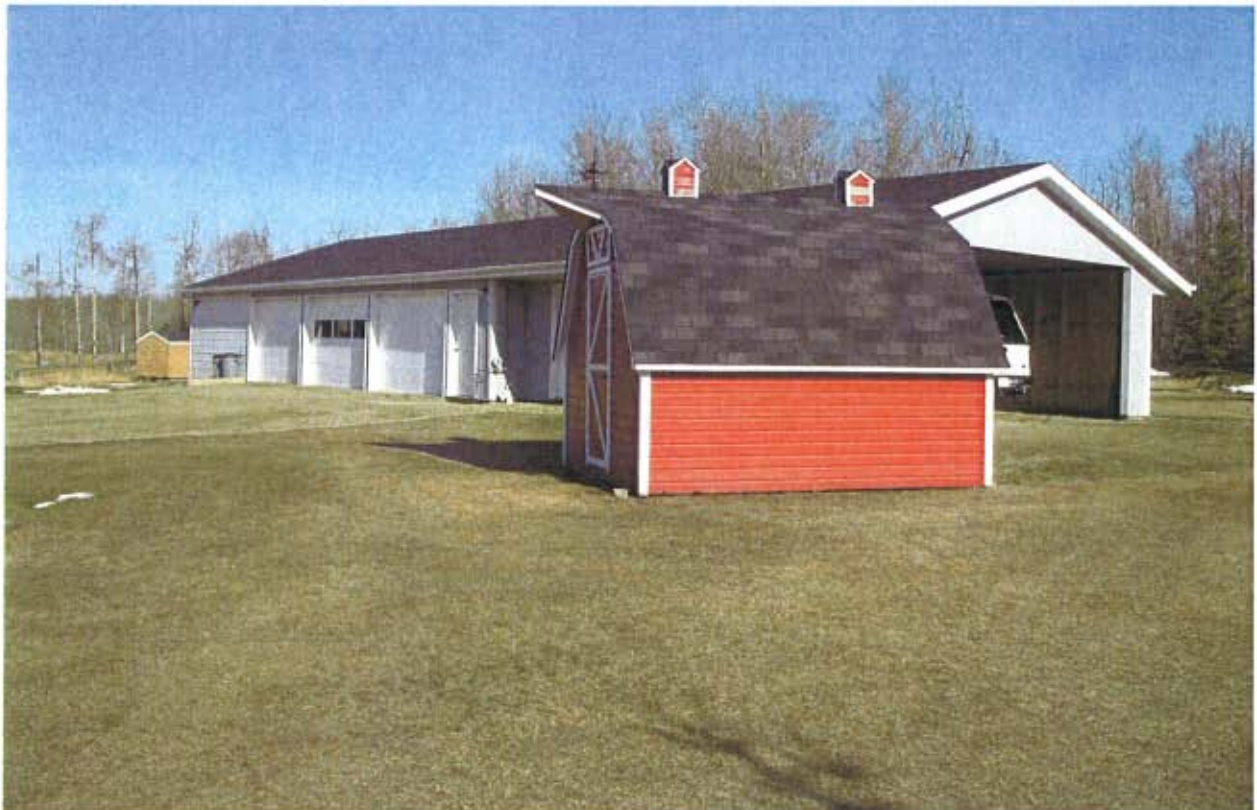
Plate 2: The shop and a shed as viewed from the southeast. The carport addition to the shop is visible on the right.

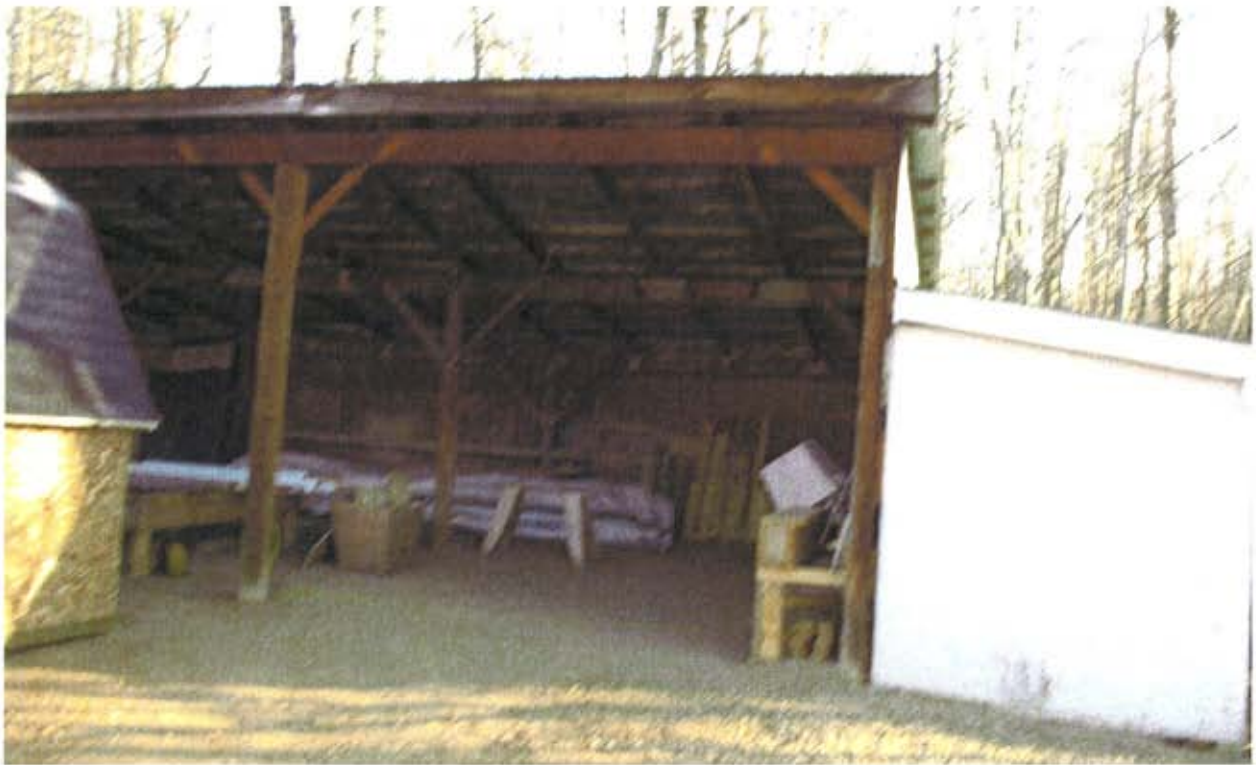
Plate 3: A view of the southeast portion of the storage building located to the northwest of the shop. Sheds are visible to the right and left.

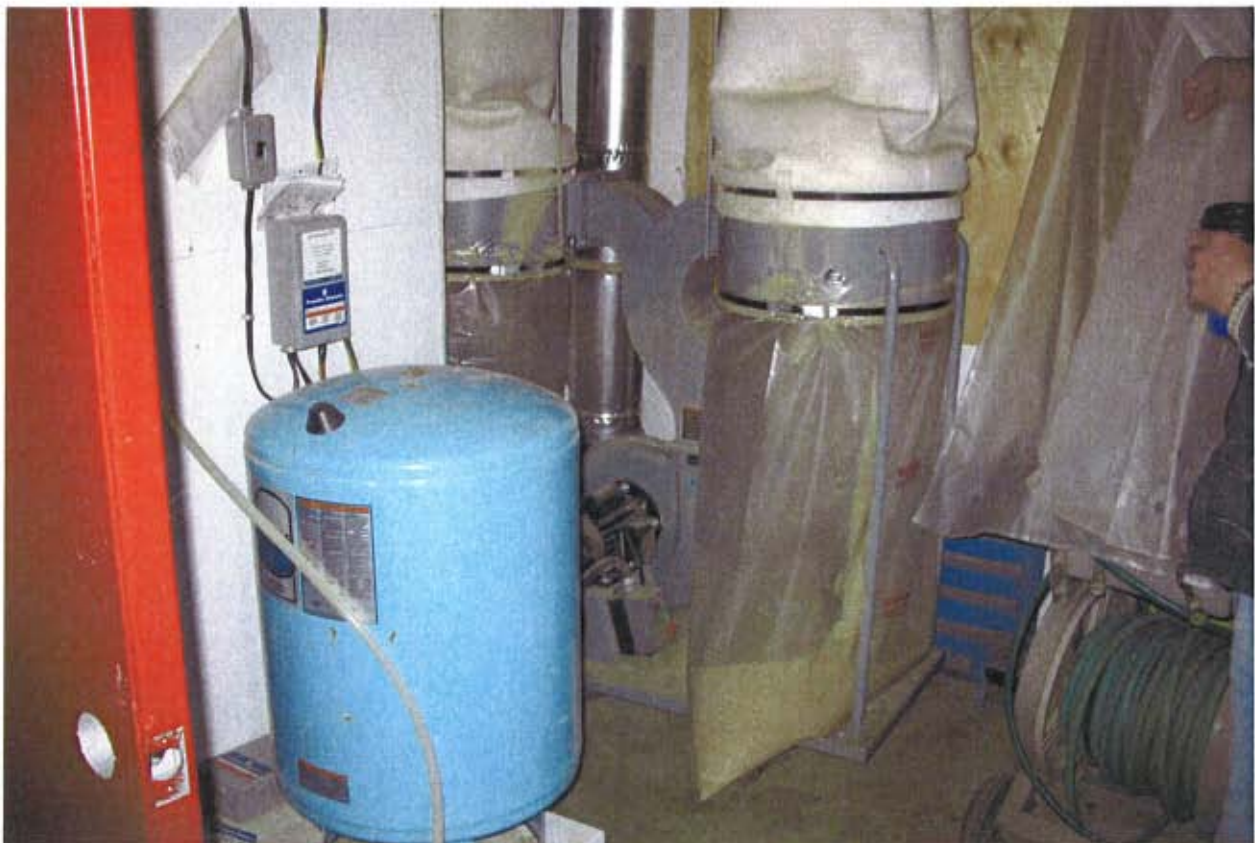
Currently, the shop is used by the Site resident for woodworking. Air extraction systems are in place to collect sawdust from equipment used inside the building. The sawdust is collected in a bag system and disposed of or burned (Plate 4; Appendix B).

Plate 4: Air extraction systems are in place to collect sawdust from equipment used inside the shop. The sawdust is collected in a bag system, as shown above, for eventual disposal.

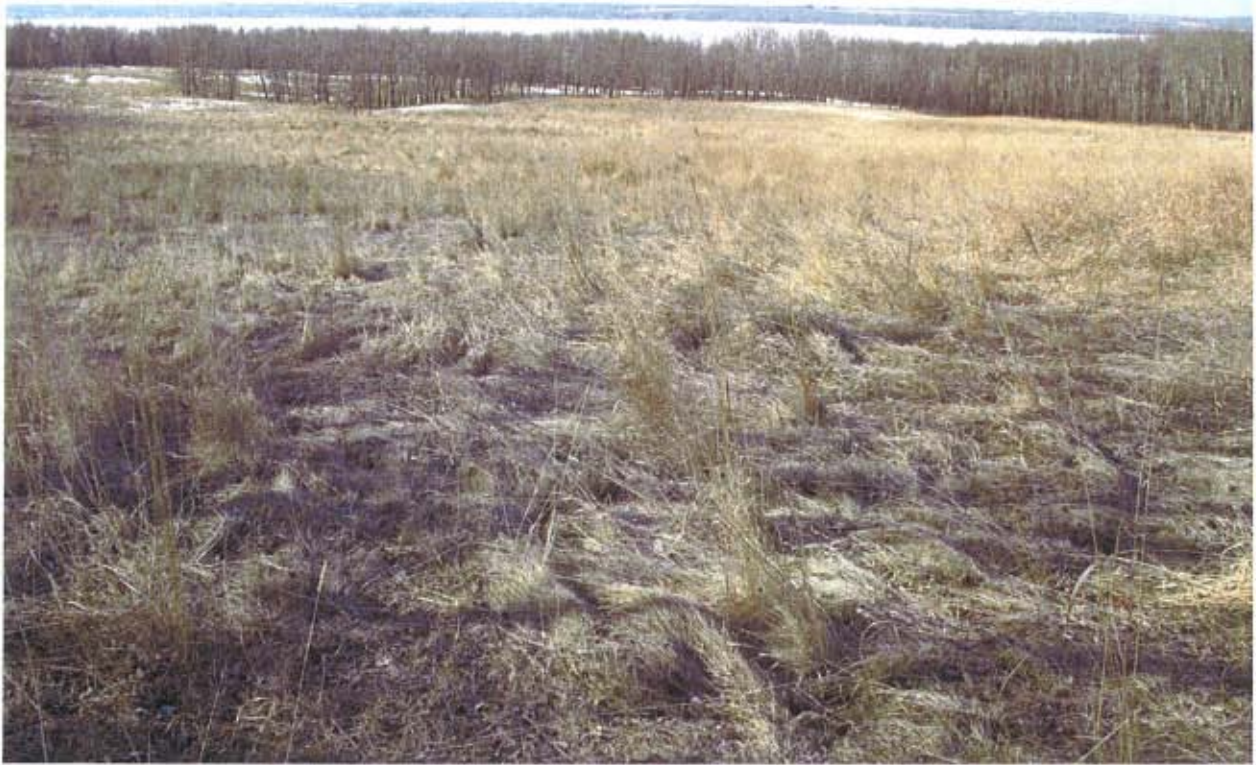
Plate 5: The Site as viewed from the north. Sylvan Lake is visible in the background.

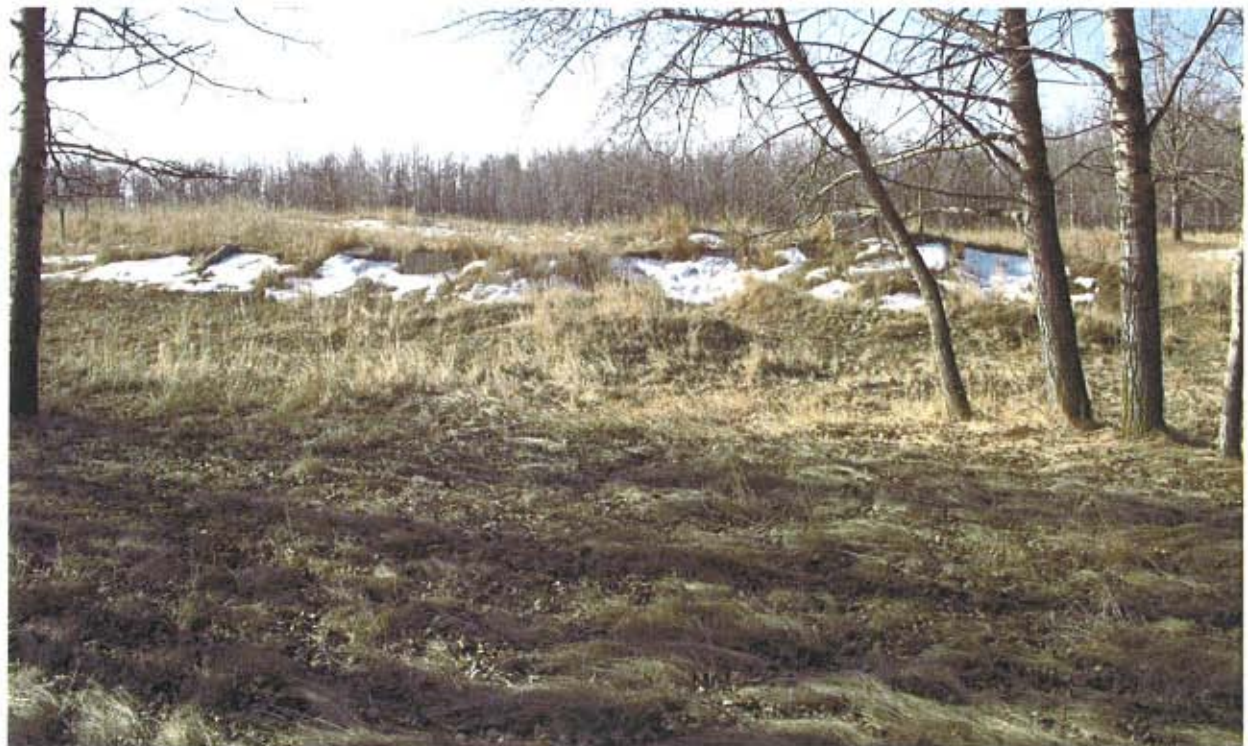
At the time of the inspection, portions of the Site were covered with up to 0.1 metres of snow. The Site generally appeared to be in a neat and orderly manner. An area showing evidence of excavation, possibly gravel extraction, was noted approximately 150 metres to the northwest of the storage building (Plate 6; Appendix B). This disturbed area covered an area of approximately 1.5 hectares and was vegetated with grasses and other weedy growth. Pieces of concrete pipe and rocks were observed in this area. According to Mr. Tronnes, these materials were placed in this area to build an obstacle motocross course for motorbikes. No staining or evidence of wastes or chemicals was observed on the Site.

Plate 6: An area showing evidence of excavation, as shown above, was noted approximately 150 metres to the northwest of the storage building. This disturbed area covered an area of approximately 1.5 hectares and was vegetated with grasses and other weedy growth. Pieces of concrete pipe and rocks were observed in this area and, according to the Site owner, were placed in this area to make an obstacle course for motorbike racing.
