Shoreline and Fish Habitat Assessment

Section 1-041-01-W5M and Portion of
S ½-12-041-01-W5M
Gull Lake, Alberta

Ms. Jacqueline Penn
A.D. Williams Engineering Inc.

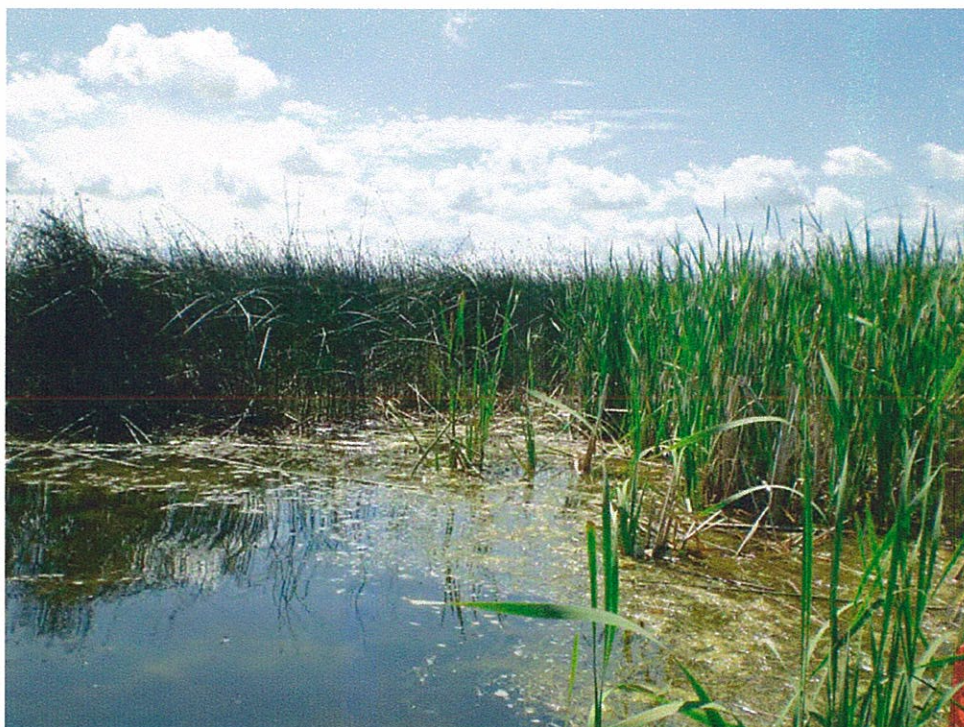
Figure 5: Sampling Location #1 (Location Reference T01 in Figure 1)

The east-facing shoreline is located along the eastern portion of the Site and includes sampling locations T-01 to T-13. This area is situated in a bay protected from the northwest prevailing winds and natural wave action. The predominate sediment types along this section are fines consisting of organics, sand, silt, and clay. The area most susceptible to erosion in this section is found on sandy sediments between sampling location T-10 and T-13.

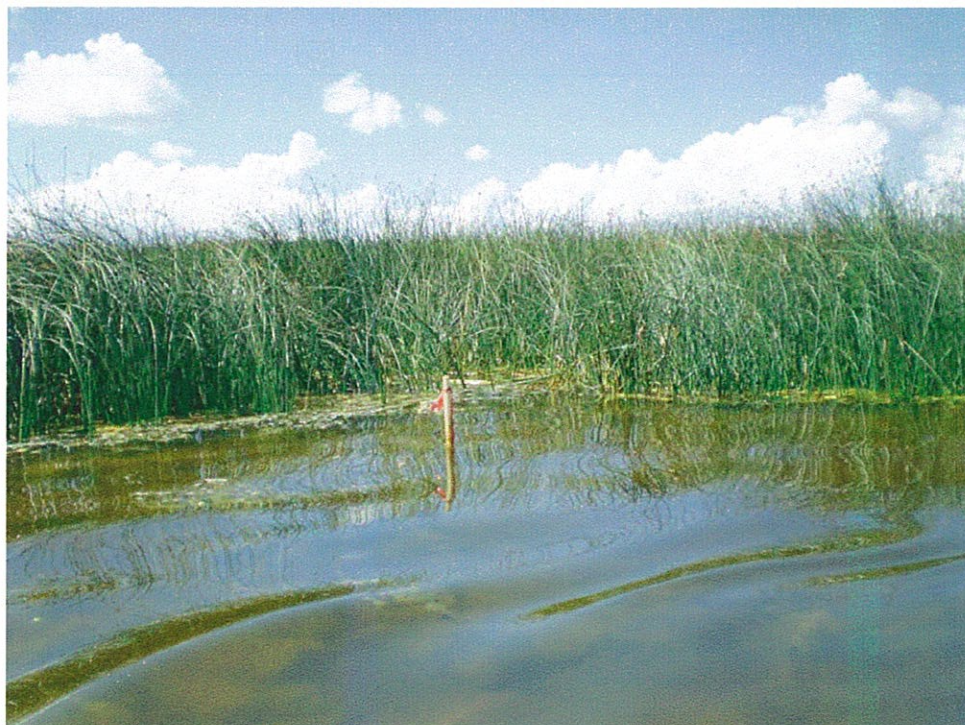
Figure 6: Sampling Location #2 (Location Reference T02)

Water quality parameters were measured in the field at sampling location T-02, T-05, and T-10 at depths ranging from 0.58 to 0.60 meters. Water pH was measured from 9.1 to 9.07 and water temperature ranged from 21.2 to 23.0 degrees Celsius. Turbidity ranged from 1.14 FTU to 5.22 FTU and dissolved oxygen ranged from 10.58 to 11.31 milligrams per liter. Electrical conductivity ranged from 1254 to 1263 micro-Siemens per centimeter. The laboratory results indicate total suspended solids ranged from 7 to 43 milligrams per liter and turbidity ranged from 4.2 to 11.5 NTU in this area. Total organic carbon ranged from 19.9 to 20.6 milligrams per liter.

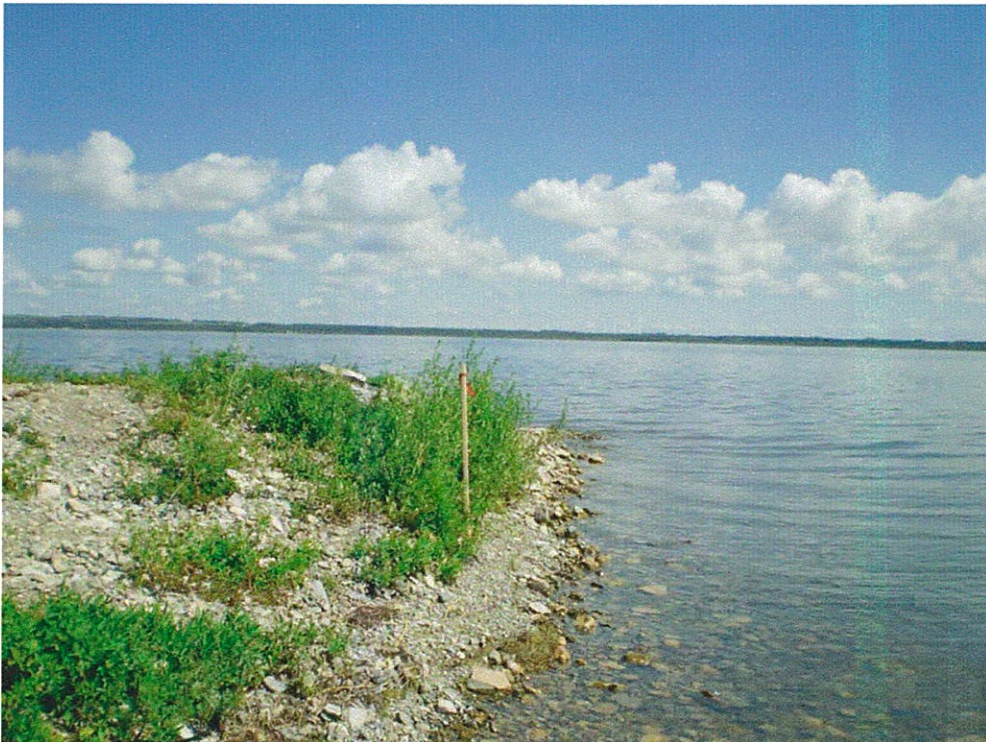
Figure 18: Sampling Location #14 (Location Reference T14)

Sandy Point is a small rocky peninsula that extends into Gull Lake at the northeast corner of the Site and includes sampling locations T-14 and T-15. The predominant sediment type along this section includes small gravels, large gravels, cobbles, and boulders with some fines (i.e. sand) in interspaces. No emergent or submergent aquatic macrophytes were detected along Sandy Point.

Water quality parameters were measured in the field at T-14 at a depth of 0.73 meters. Water pH was measured at 9.02 and temperature was recorded at 21.1 degrees Celsius. Turbidity was measured at 15.25 and dissolved oxygen was measured at 8.55 milligrams per liter. Electrical conductivity was measured at 1254 micro-Siemens per centimeter. The laboratory results measured total suspended solids at 4 milligrams per liter and turbidity at 4.8 NTU. Total organic carbon was measured at 20.8 milligrams per liter.

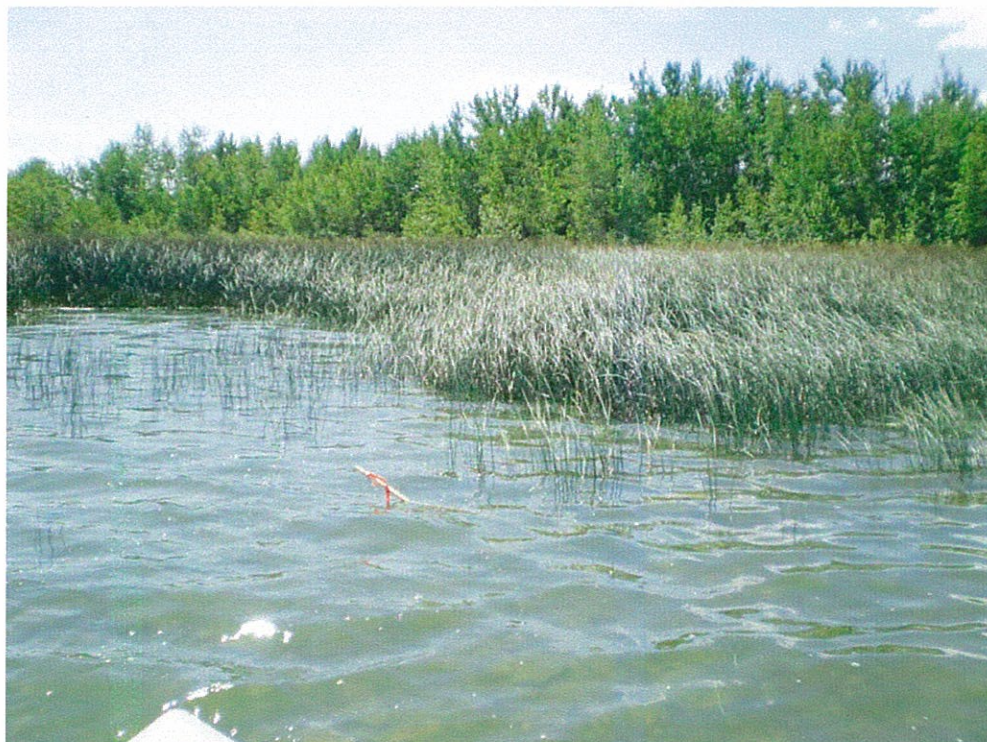
Figure 20: Sampling Location #16 (Location Reference T16)

Common great bulrush (*Scirpus lacustris* spp. *validus*) was the only type of emergent aquatic vegetation observed along this section and was of relatively low stature throughout, except at sampling location T-16. Sparse beds of northern watermilfoil (*Myriophyllum exalbescens*) were observed near sampling location T-18.

The rocky shoreline provided habitat for American white pelican (*Pelecanus erythrorhynchos*) near sampling location T-16. American crow (*Corvus brachyrhynchos*) was also observed in this area of the Site. No other wildlife was detected.

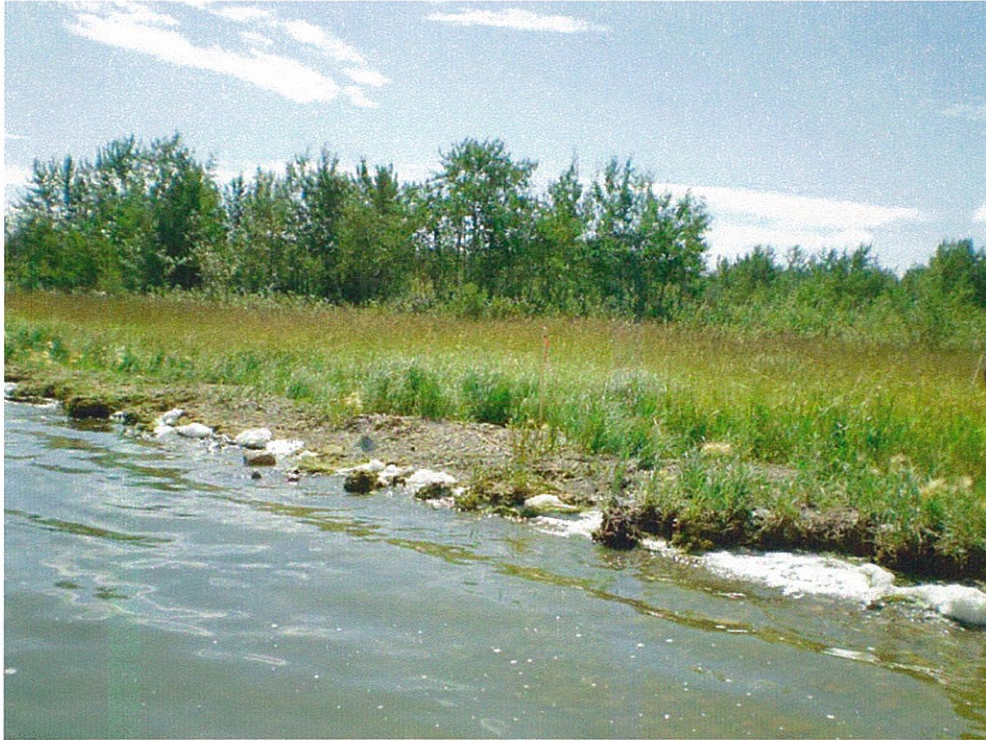
Figure 23: Sampling Location #19 (Location Reference T19)

Water quality parameters were measured in the field at T-19 at a depth of 0.20 meters. Water pH was measured at 8.98 and temperature was recorded at 21.5 degrees Celsius. Turbidity was measured at 28.10 and dissolved oxygen was measured at 8.72 milligrams per liter. Electrical conductivity was measured at 1252 micro-Siemens per centimeter. The laboratory results measured total suspended solids at 3 milligrams per liter and turbidity at 1.8 NTU. Total organic carbon was measured at 22.4 milligrams per liter.
