Reference: Palm Cove Biophysical Update Letter

Stantec Consulting Ltd. (Stantec) was retained by Qualico Developments West (Qualico) to complete a biophysical update for the Palm Cove development located within W ½ 34-039-02 W5M in Lacombe County, AB (Study Area) (Figure 1).

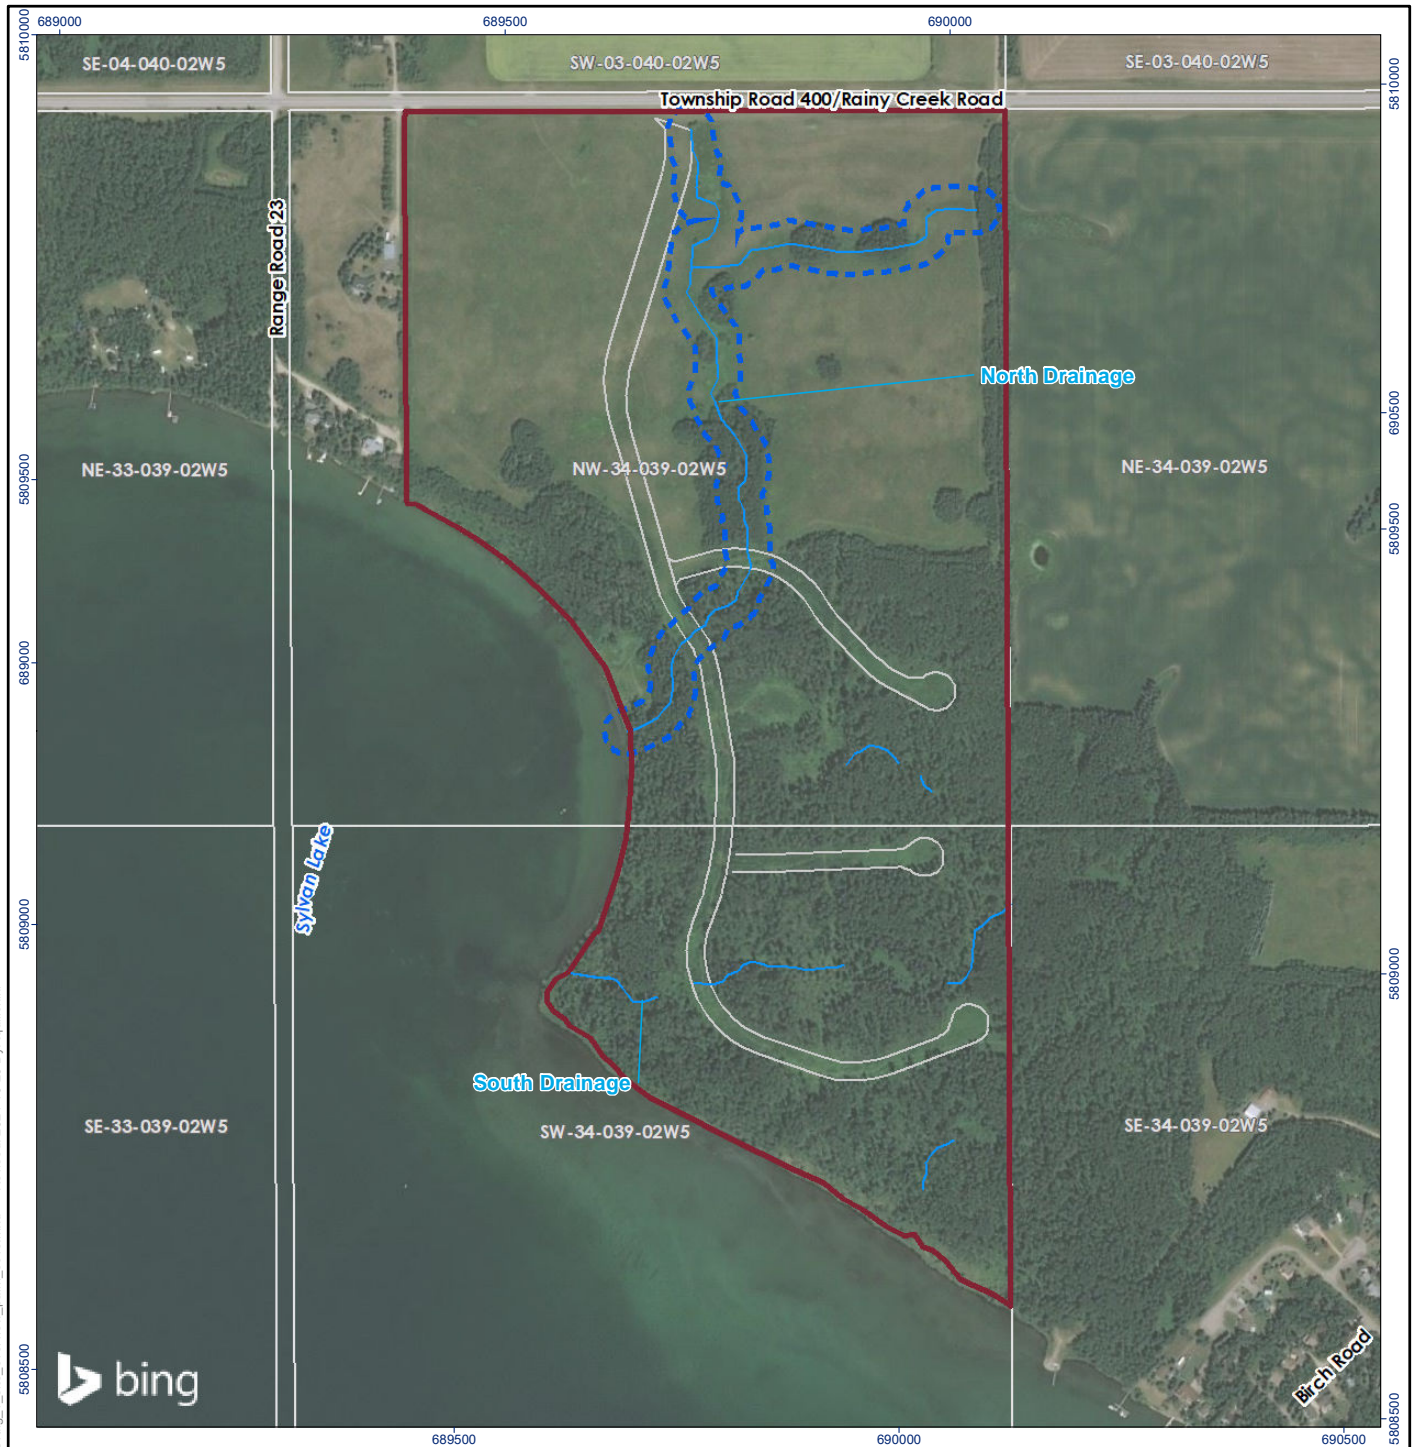
Figure No.

Site Overview

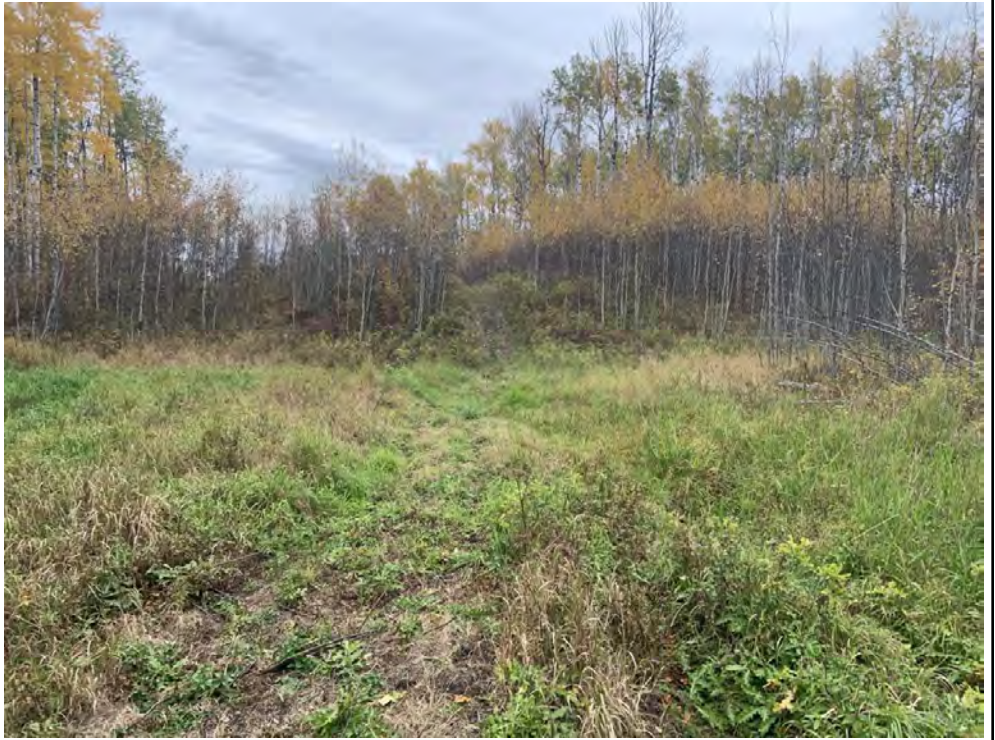
Client:	Qualico Communities	Project:	Palm Cove Biophysical Update
Site Name:	Palm Cove	Site Location:	W1/2 34-039-02 W5M
Photograph ID: 1

Photo Location: R1			
Direction: North			
Survey Date: 9/30/2021			
Comments: Showing road clearing			
Photograph ID: 2

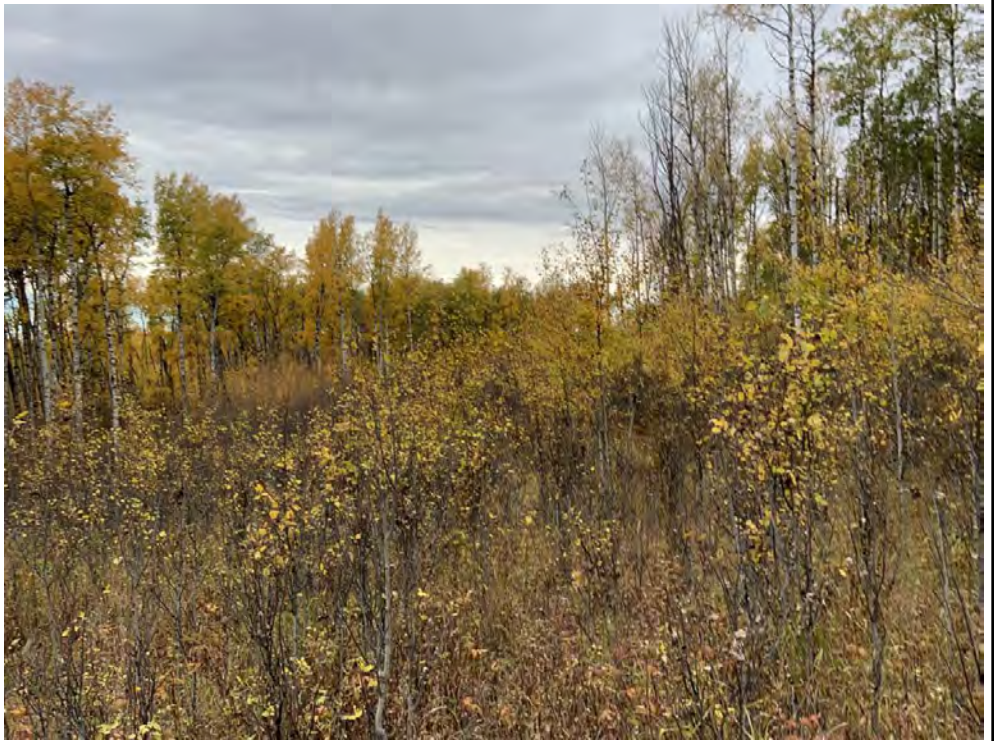
Photo Location: R8			
Direction: West			
Survey Date: 9/30/2021			
Comments: Showing road clearing

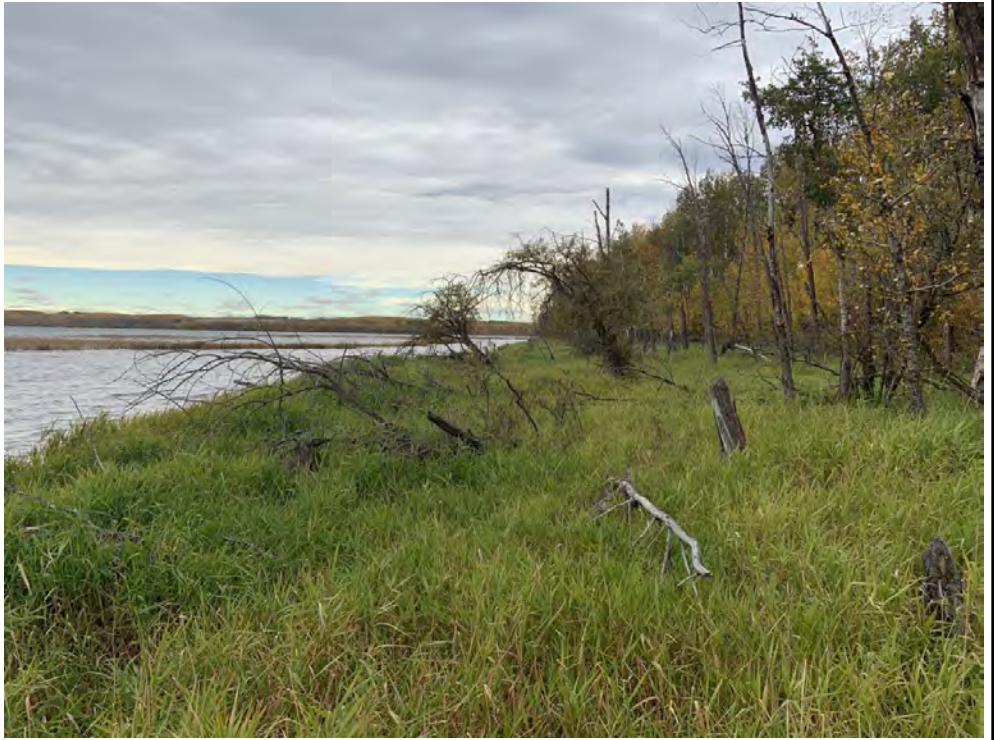
Client:	Qualico Communities	Project:	Palm Cove Biophysical Update
Site Name:	Palm Cove	Site Location:	W1/2 34-039-02 W5M
Photograph ID: 5

Photo Location: R3			
Direction: Northeast			
Survey Date: 9/30/2021			
Comments: Showing south shoreline			
Photograph ID: 6

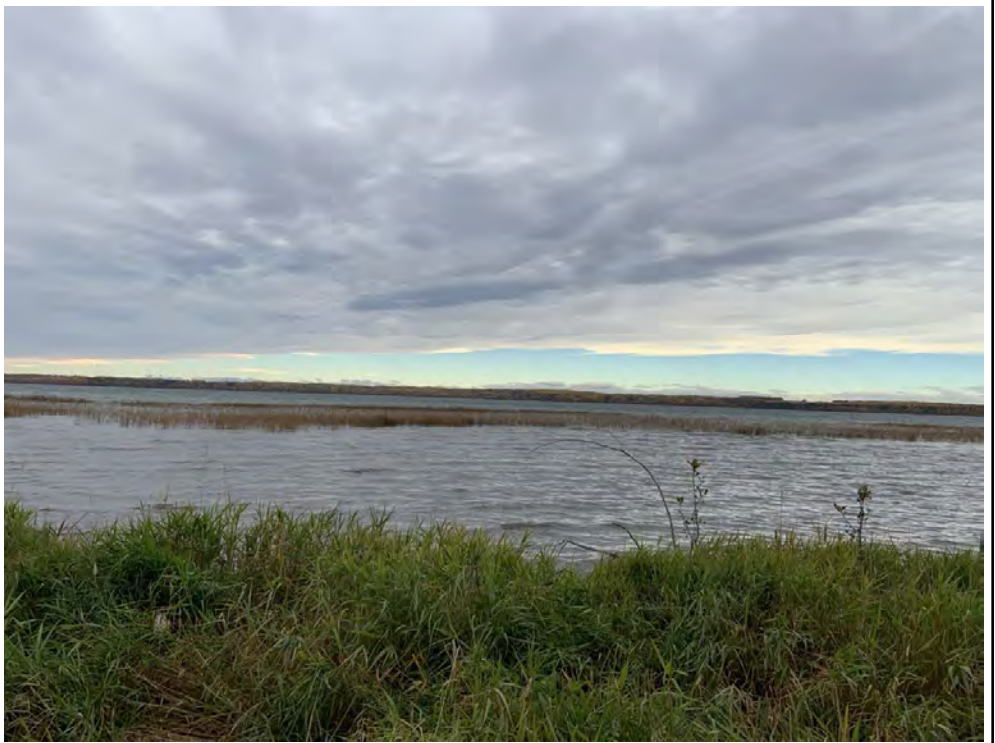
Photo Location: R3			
Direction: Southwest			
Survey Date: 9/30/2021			
Comments: Showing south shoreline

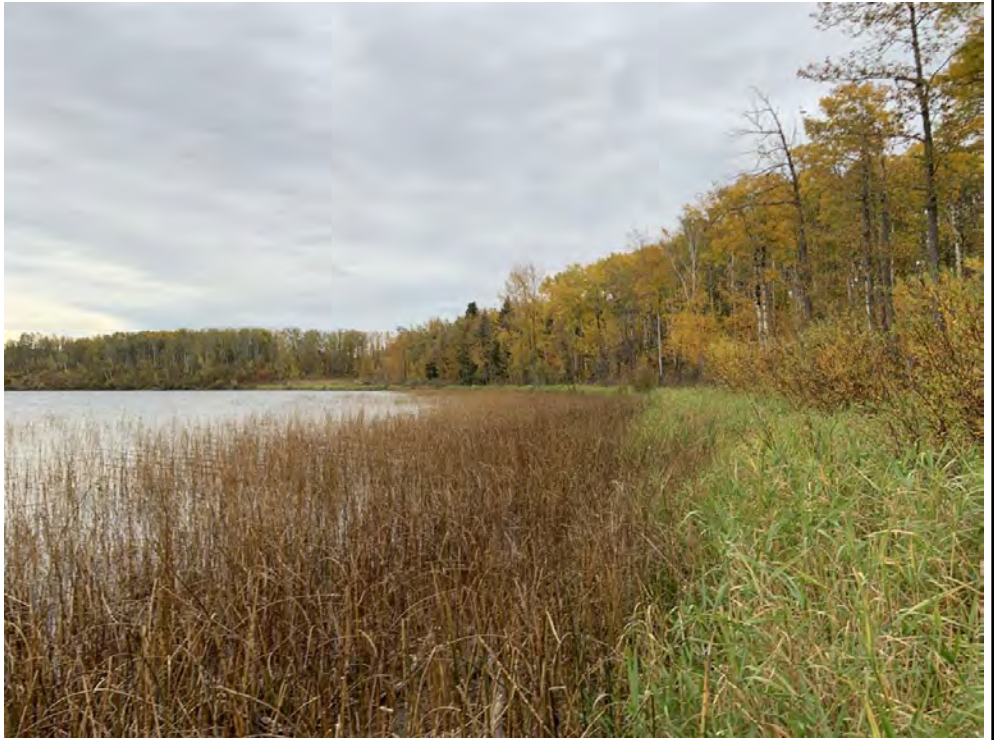
Client:	Qualico Communities	Project:	Palm Cove Biophysical Update
Site Name:	Palm Cove	Site Location:	W1/2 34-039-02 W5M
Photograph ID: 7

Photo Location: P03			
Direction: Northeast			
Survey Date: 9/30/2021			
Comments: Showing west shoreline			
Photograph ID: 8

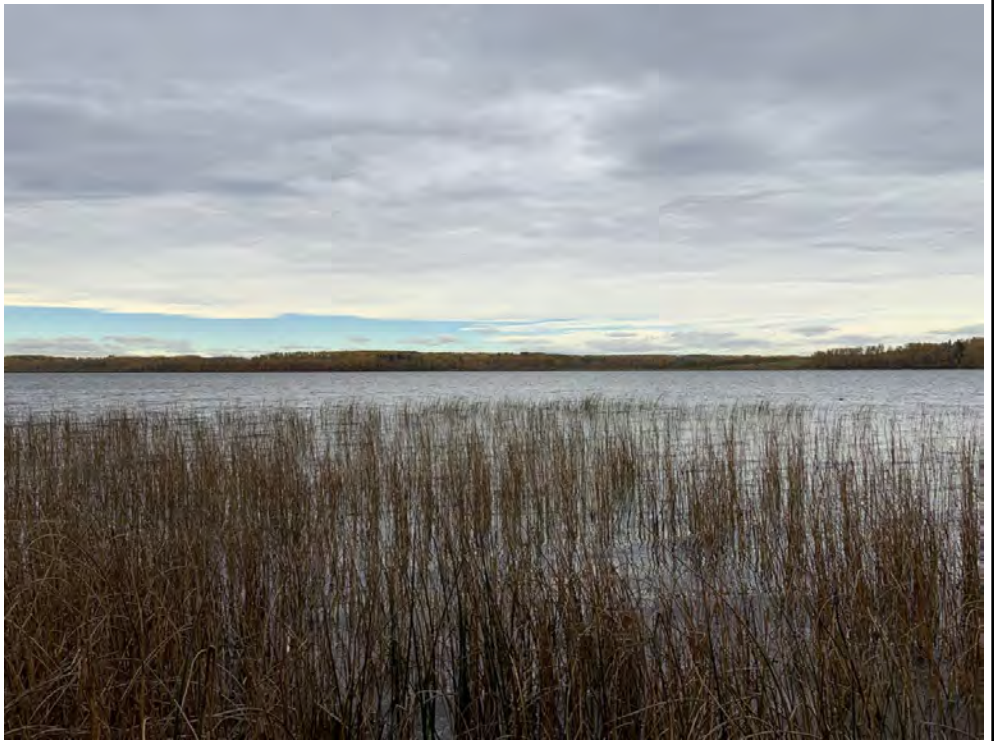
Photo Location: P03			
Direction: West			
Survey Date: 9/30/2021			
Comments: Showing west shoreline

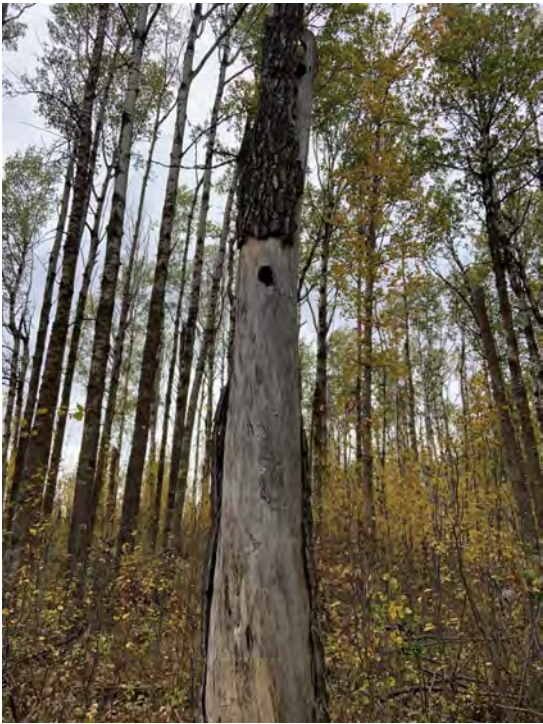
Client:	Qualico Communities	Project:	Palm Cove Biophysical Update
Site Name:	Palm Cove	Site Location:	W1/2 34-039-02 W5M
Photograph ID: 9

Wildlife incidental observations were also recorded during the field assessment. One snag with a potential woodpecker cavity was observed within the forest near the shoreline but there was no evidence of recent activity. Various game trails were seen throughout the forested area. Multiple horses were observed throughout the forested areas and are likely contributing to the trails through the forested area.

Photo Location: R4			
Direction: North			
Survey Date: 9/30/2021			
Comments: Cavity in tree snag			
Photograph ID: 10

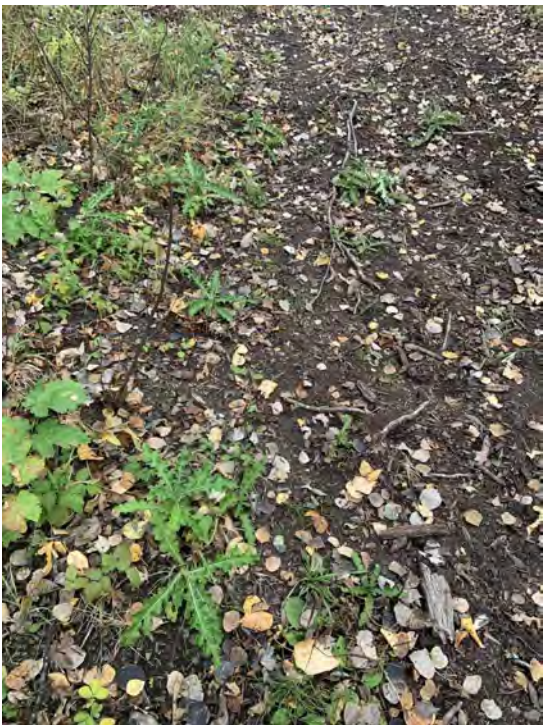
The 2010 original biophysical report identified *noxious* weed species creeping thistle (*Cirsium arvense*) and perennial sow-thistle (*Sonchus arvensis*). The majority of the *noxious* weed species were within the agricultural land, the north drainage area and on the fringe of where the agricultural area transitions to the main forested area to the south although creeping thistle was observed within wetland areas as well. These species were observed in 2021. However, because parts of the forest have been cleared for future road construction, the presence and distribution of *noxious* weed species has spread within the disturbed areas. *Noxious* weeds were observed in low to moderate densities (occasional to scattered plants between 1% and 25% cover) in the cleared areas associated with the future road. Weeds were present in these densities on all parts of the cleared area for the proposed future road, with higher percent covers of weeds were typically observed in low spots and high disturbance (e.g., rutting in road) areas. *Noxious* weeds were typically not observed in the forested areas except in wetlands.

Photo Location: P01			
Direction: NA			
Survey Date: 9/30/2021			
Comments: Showing creeping thistle on road clearing

Weed control measures are recommended to be implemented both during construction of the proposed development and after construction of the proposed development to prevent further spread and establishment of weeds throughout the Study Area. This should include cleaning construction equipment prior to entering and leaving the Study Area to prevent new establishment and spread of weeds, not using topsoil from areas with weeds for landscaping within the development and implementing active weed control measures such as tillage, mowing or chemical control. Weed management will require multiple treatments over multiple seasons. If herbicide application will be used, it must be done by a licensed professional in accordance with provincial legislation.
