PHASE 2 ENVIRONMENTAL SITE ASSESSMENT  
HIGHLANDS PARK LANDFILL  
SW 21-39-1-W5M  
LACOMBE COUNTY, ALBERTA

PROJECT: RD3026  
DECEMBER 2008

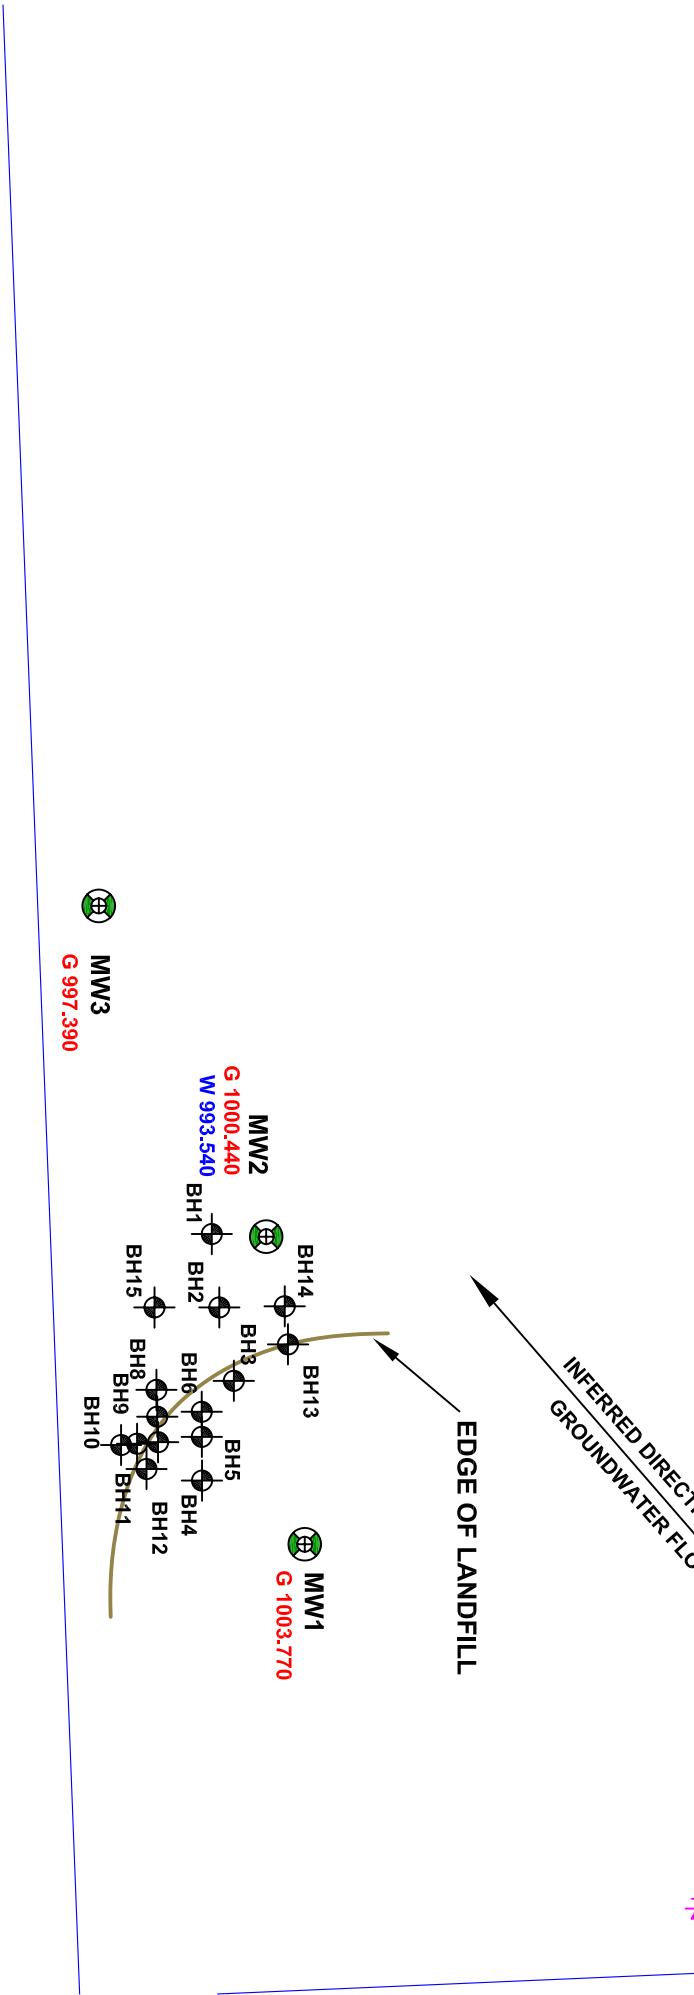
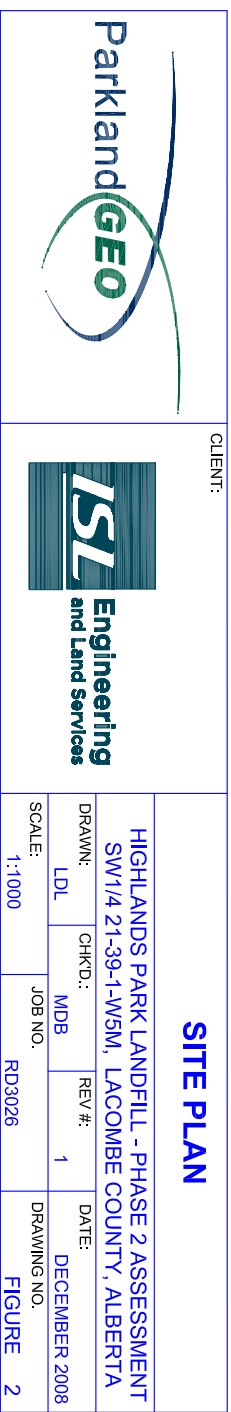
Groundwater was only observed in Monitoring Well 2. The groundwater table in the vicinity is about 6.5 to 7.0 m below grade which corresponds to an elevation of about 994 m for Monitoring Well 2. Flow of the groundwater is through the siltstone bedrock and will be dependent on fractures and fissures. Based on site observation and local experience, the groundwater flow on the site is expected to flow to the southwest towards Sylvan Lake. This groundwater elevation in Monitoring Well 2 was considered to be typical of the seasonal average for this area of the Sylvan Lake watershed. The local groundwater table will fluctuate higher during periods of snow melt and heavy or prolonged precipitation. The following table summarizes the observed groundwater conditions and elevations.

APPROXIMATE MONITORING WELL LOCATIONS

GROUNDWATER FLOW DIRECTION

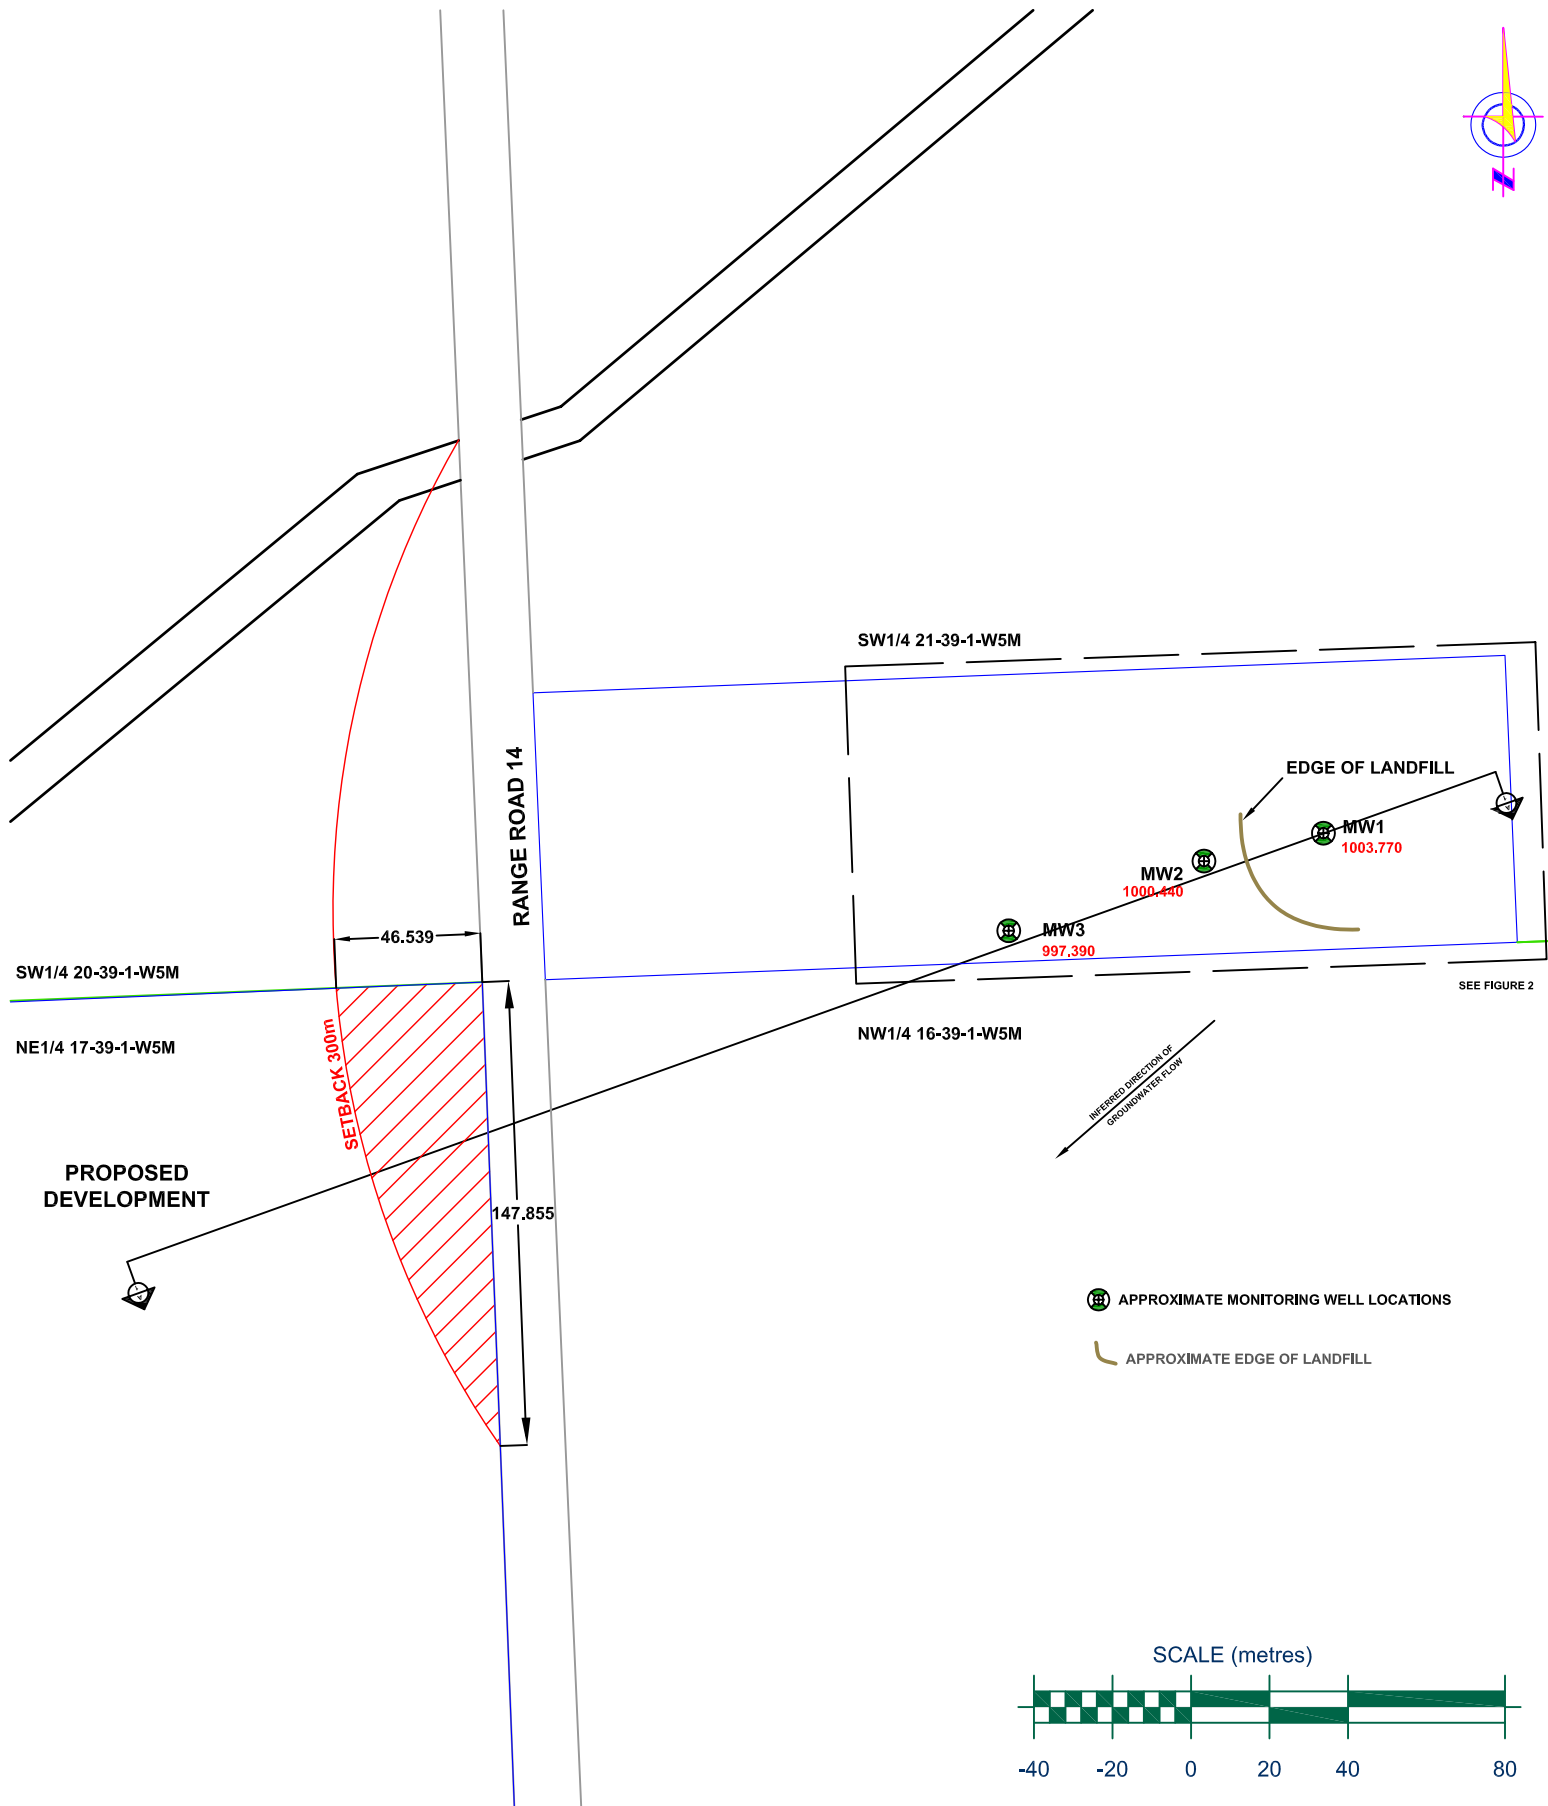
DRAWN: LDL	CHK'D.: MDB	REV #: 1	DATE: DECEMBER 2008
SCALE: 1:2500	JOB NO. RD3026	DRAWING NO. FIGURE 3

It was suspected that the 300 m regulatory setback required from the former County of Lacombe landfill in SW 21-39-1-W5M encroached on the proposed Highland Park rural residential subdivision located in NE 17-21-39-1-W5M. The western edge and southwest corner of the landfill were delineated and found to be 250 m from the closest part of the Highland Park development.

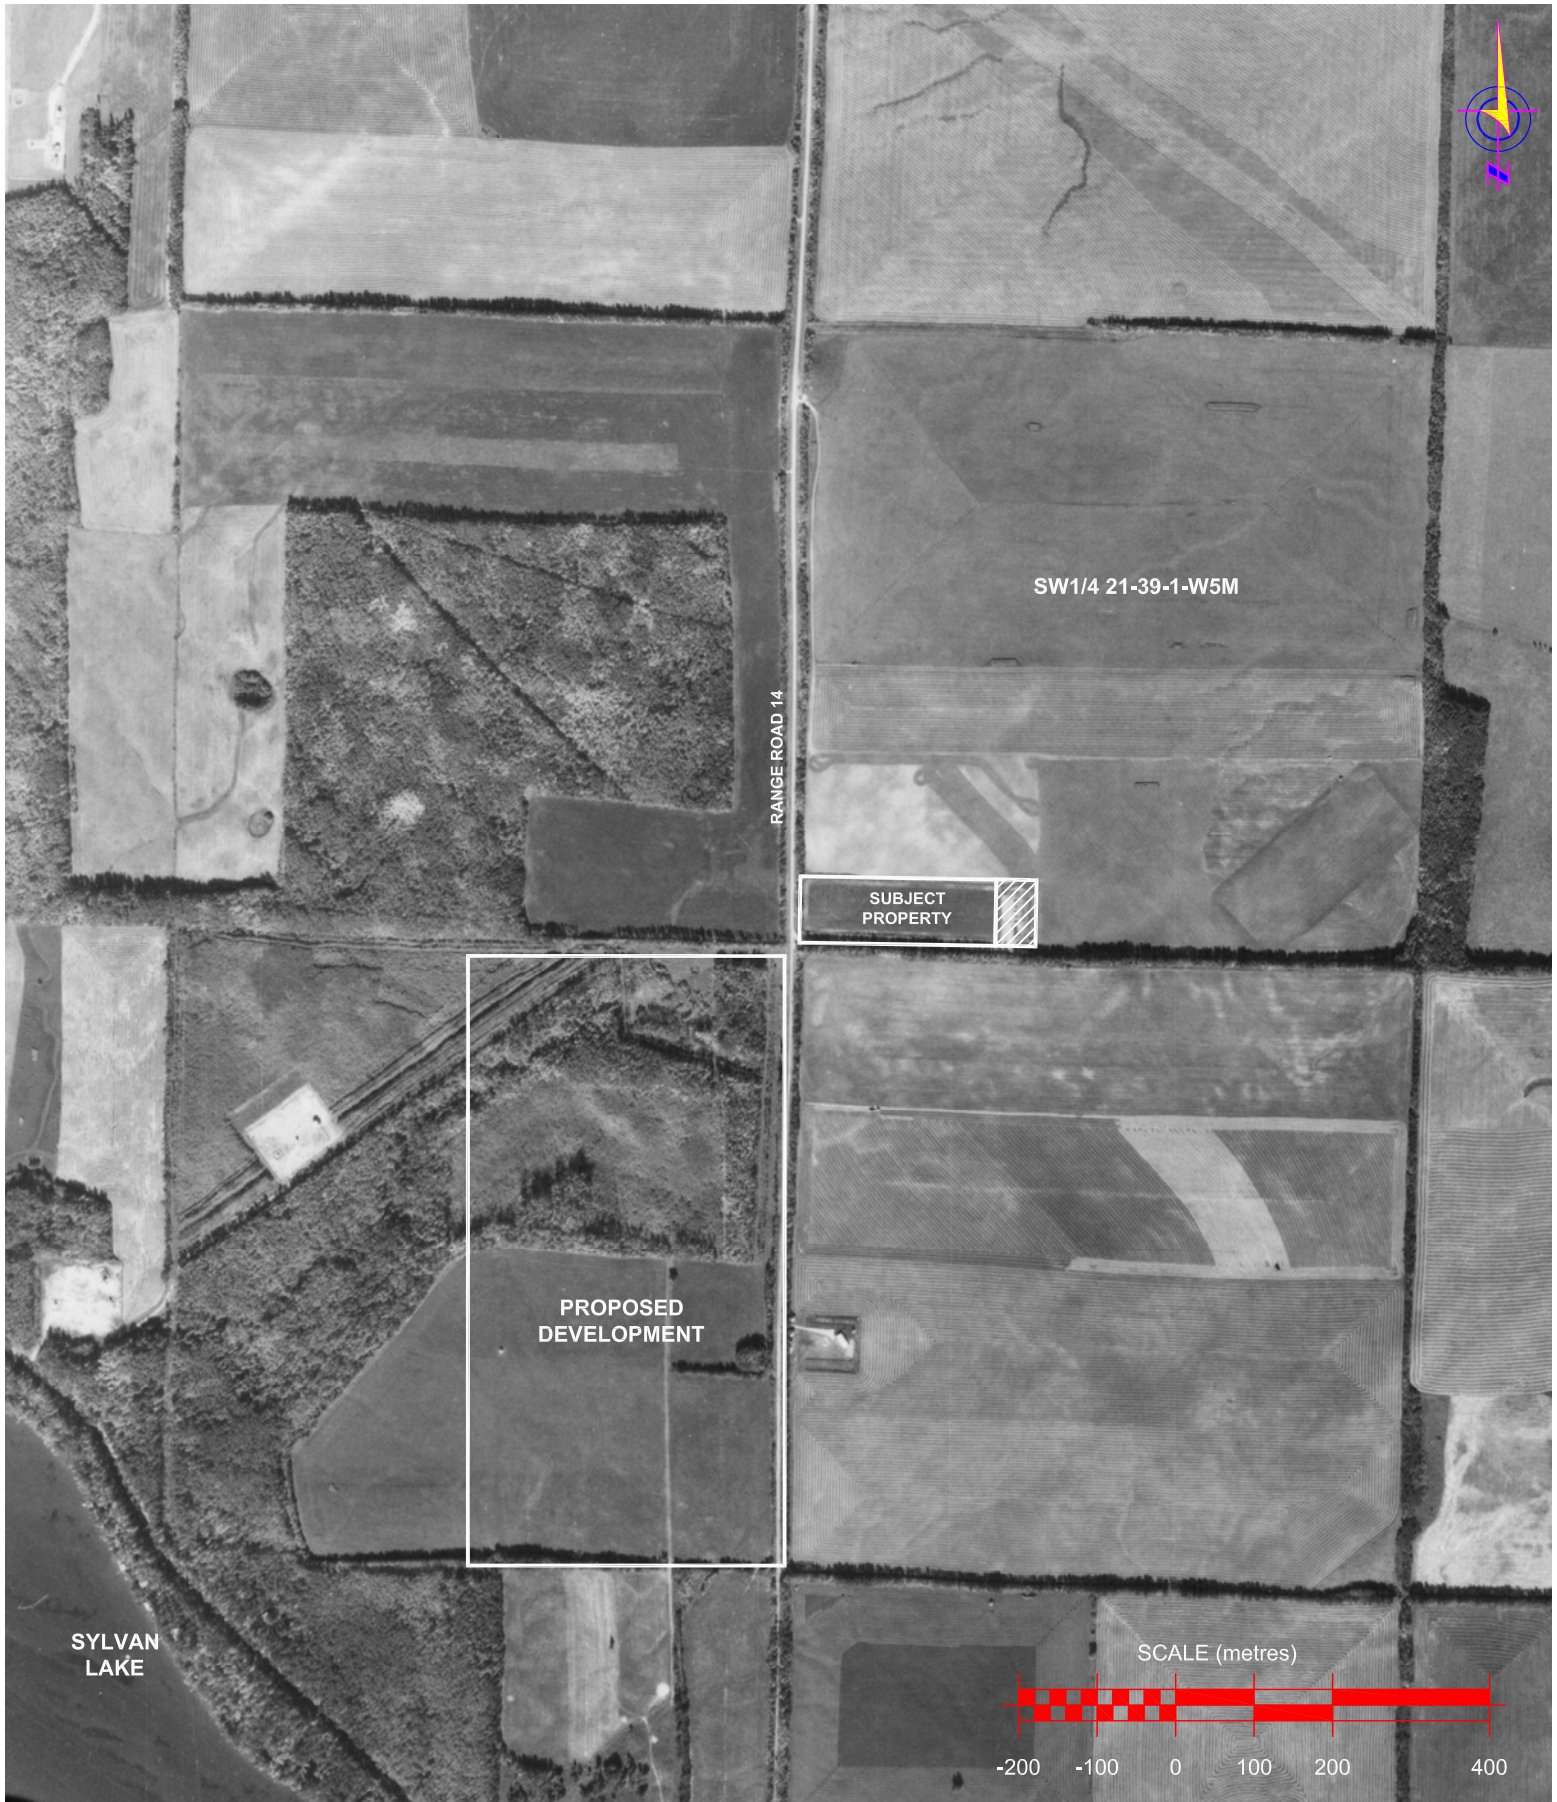
Development adjacent to a landfill must address both regulatory and technical issues. The primary technical issues for development near sanitary landfills include leachate movement and landfill gas generation. The location of the delineated landfill and its setback limit is presented in Figure 3, in Appendix A.

The western edge and southwest corner of the landfill was delineated with a series of shallow probes. Upon the completion of the drilling, the probe locations and surrounding areas were surveyed. Based on the information collected, the northeast corner of the proposed Highland Park development is 250 m from the former County of Lacombe landfill. The location of the delineated landfill and its setback limit is presented in Figure 3, in Appendix A.

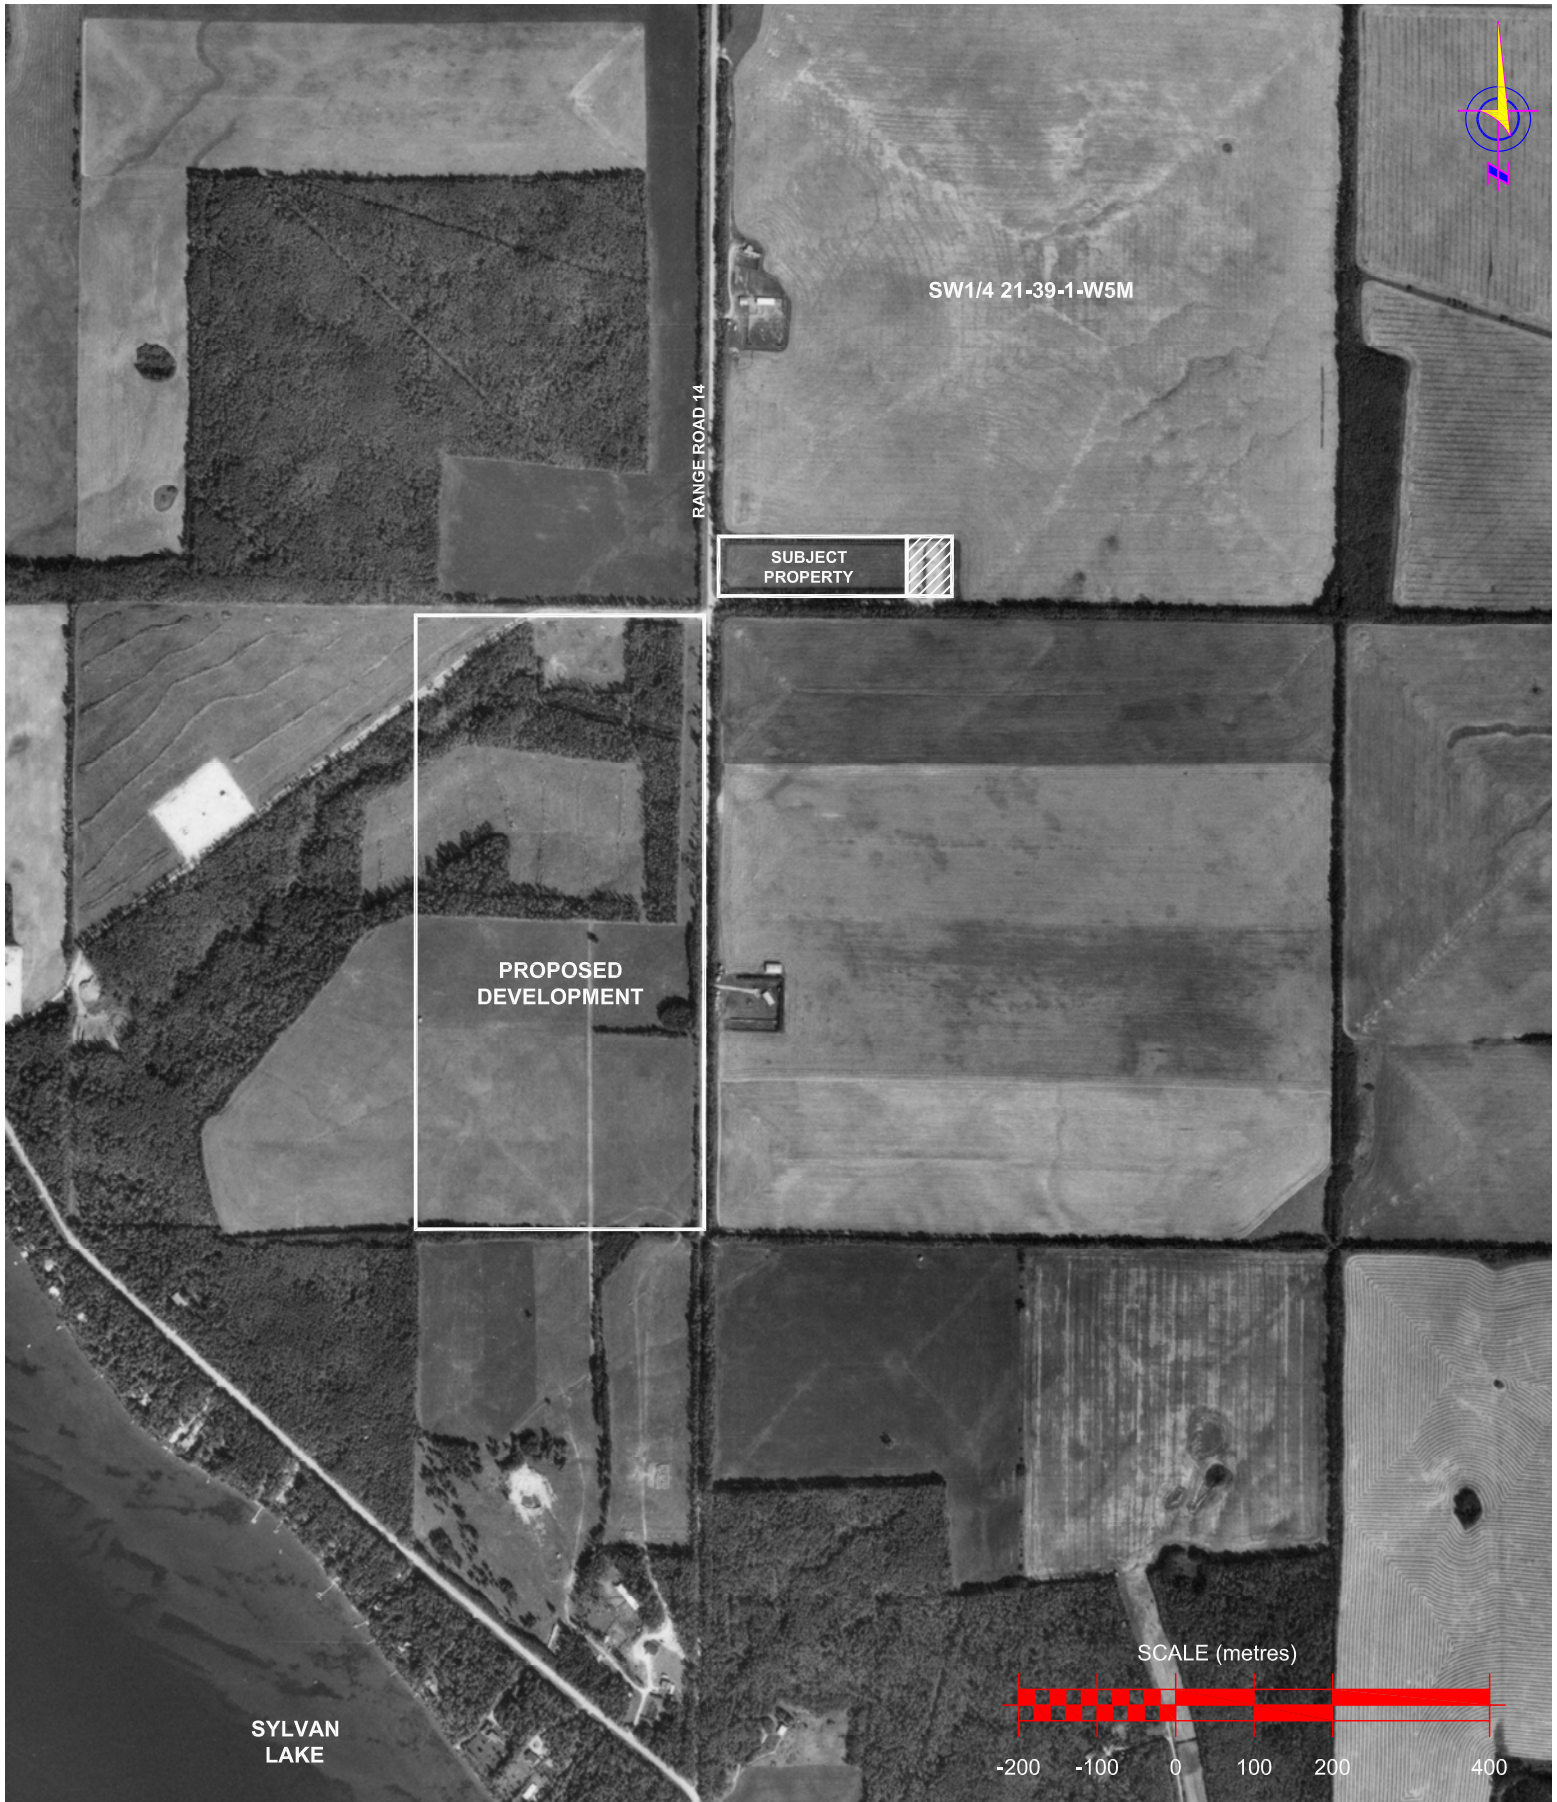
DRAWN: LDL	CHK'D.: MDB	REV #: 1	DATE: DECEMBER 2008
SCALE: 1:10000	JOB NO. RD3026	DRAWING NO. FIGURE 4

The site was used by the County of Lacombe as a landfill in the late 1970s for the disposal of household and construction waste. This is confirmed by a review of aeriels from that time. When landfill operations ceased in the mid 1980s, the site was closed, capped and allowed to return to agricultural use. Aeriels from 1978, 1982, 1987, and 2002 are shown in Figures 4 to 7 in Appendix A. The County of Lacombe and the Government of Alberta entered into a land usage agreement on January 12, 1989 with the purpose of restricting what the land could be used for. The majority of the land is currently unused grass lands with a small section in east of the site used for agricultural crops.

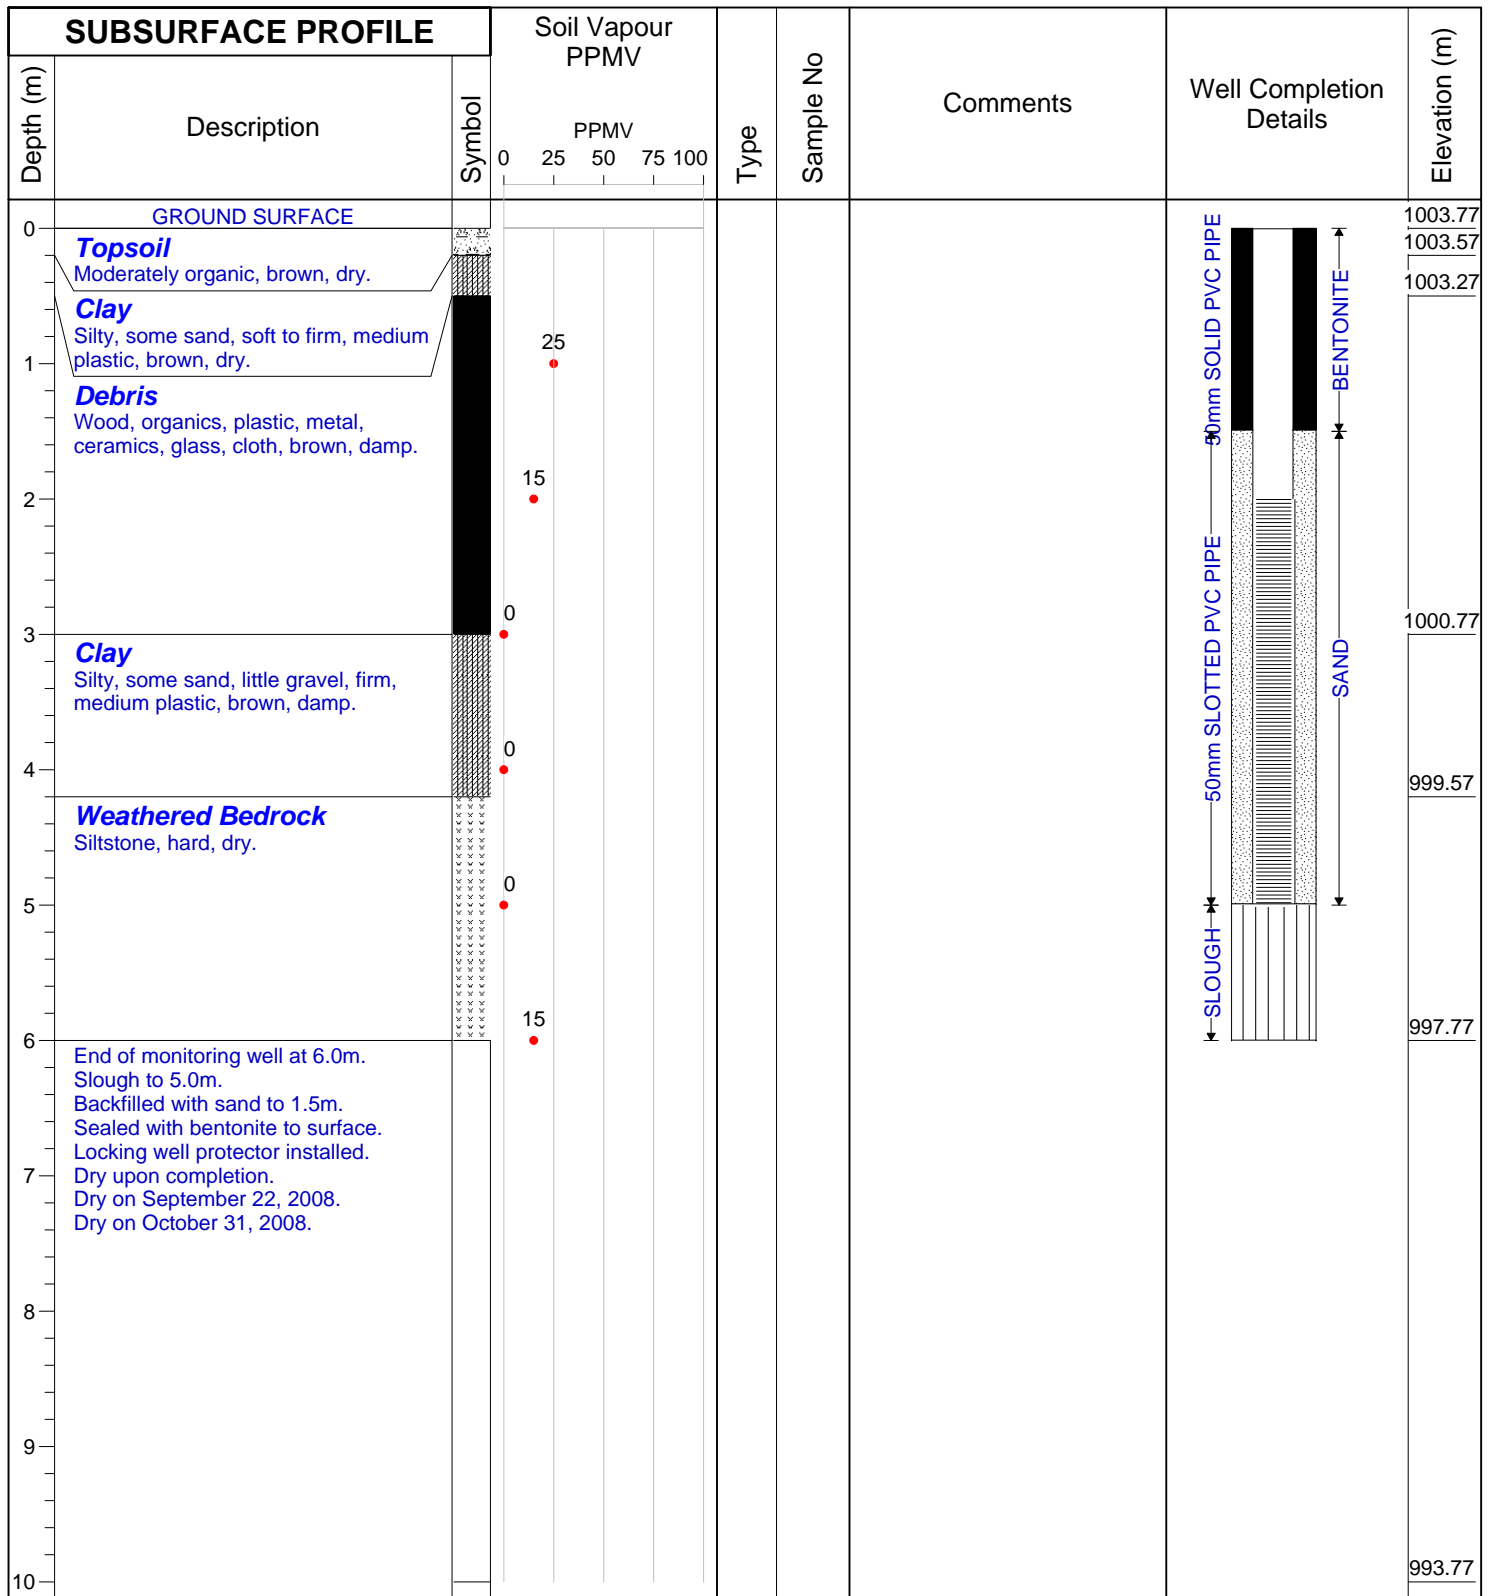
GROUND ELEVATION: 1003.772m  
 NORTHING: 5805444.006  
 EASTING: 697870.243

LOGGED BY: PA  
 CONTRACTOR: All Services Drilling Inc.  
 RIG/METHOD: Truck Mounted Auger / Solid Stem Auger  
 DATE: September 12, 2008

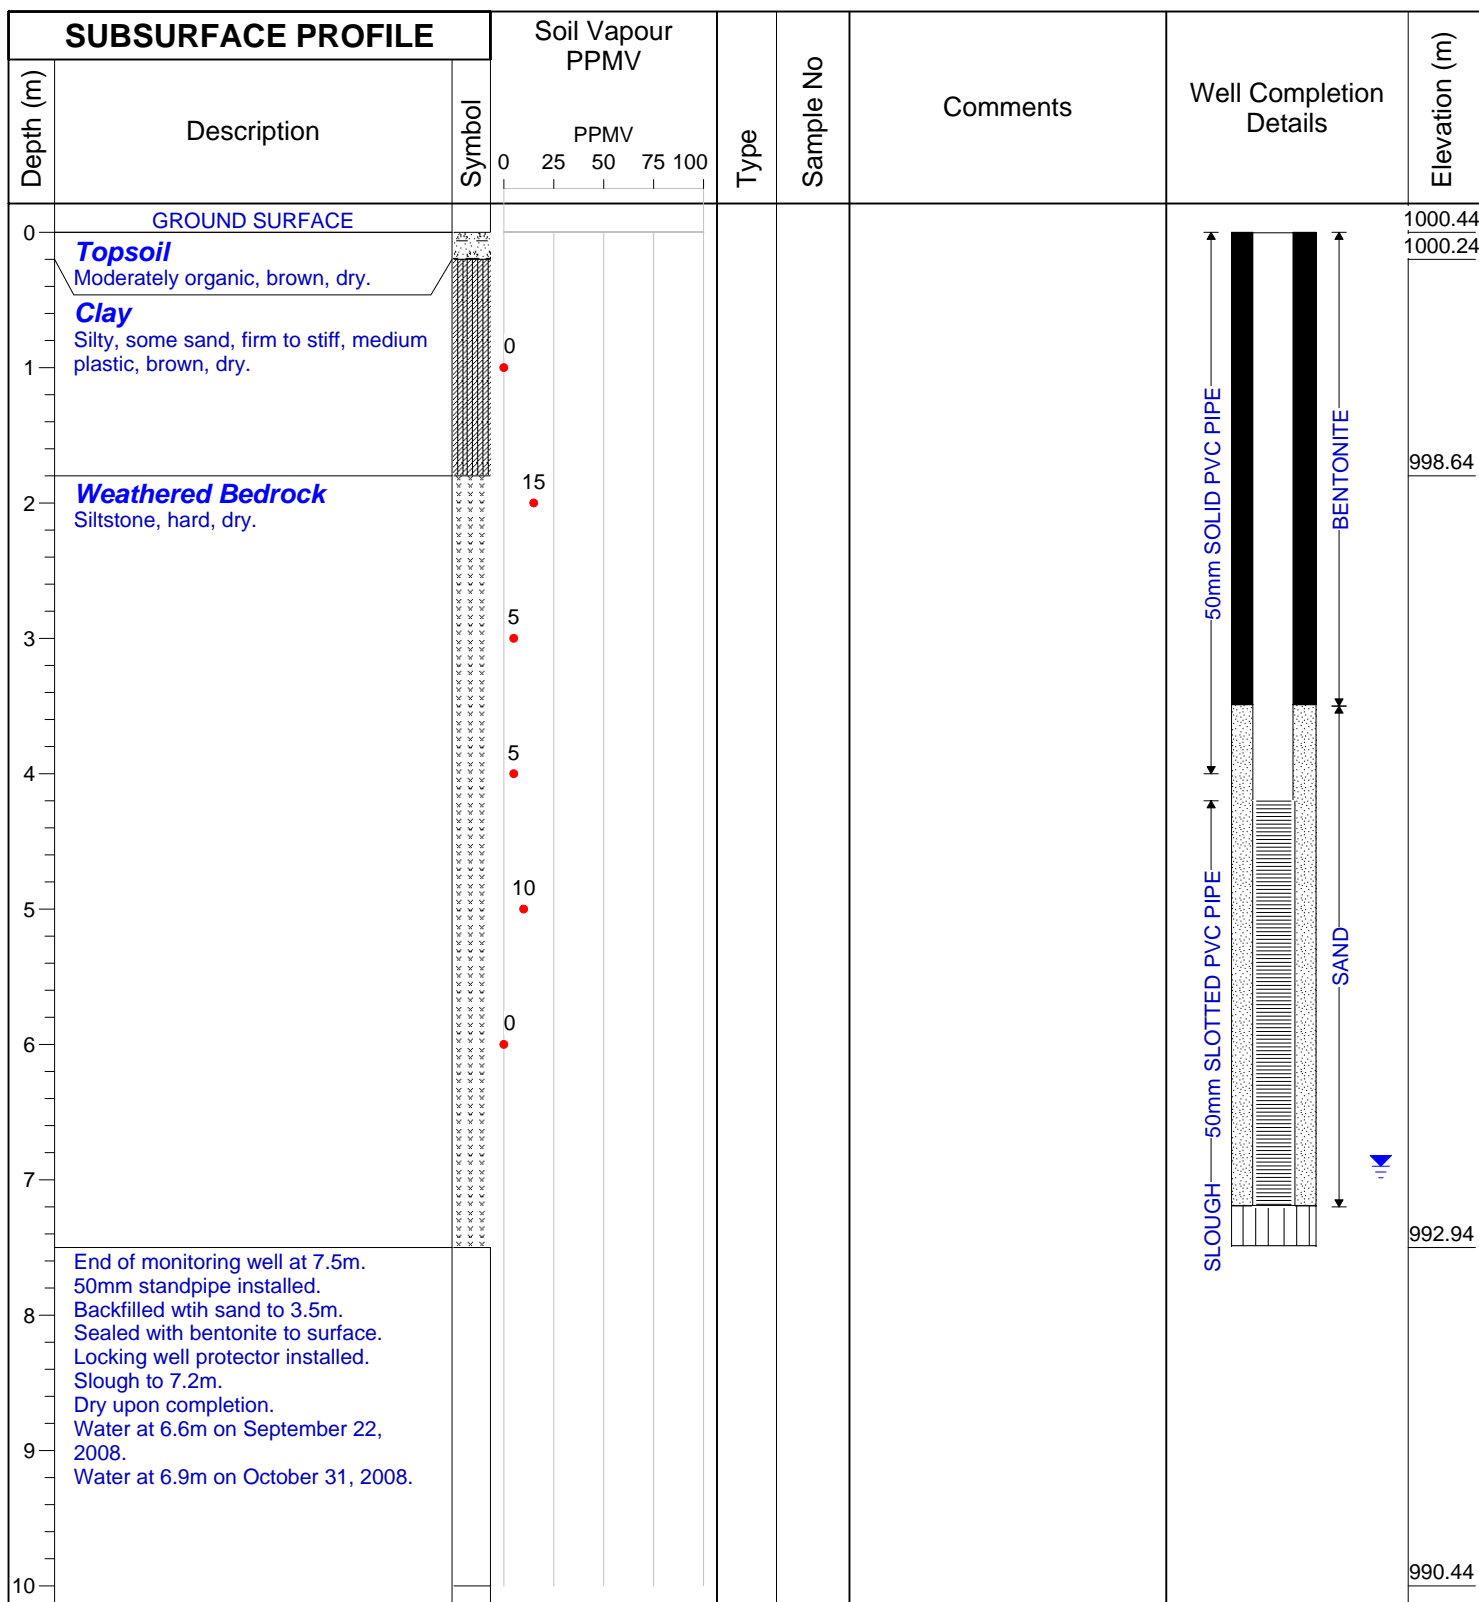
GROUND ELEVATION: 1000.443m  
 NORTHING: 5805438.909  
 EASTING: 697829.547

LOGGED BY: PA  
 CONTRACTOR: All Services Drilling Inc.  
 RIG/METHOD: Truck Mounted Auger / Solid Stem Auger  
 DATE: September 12, 2008

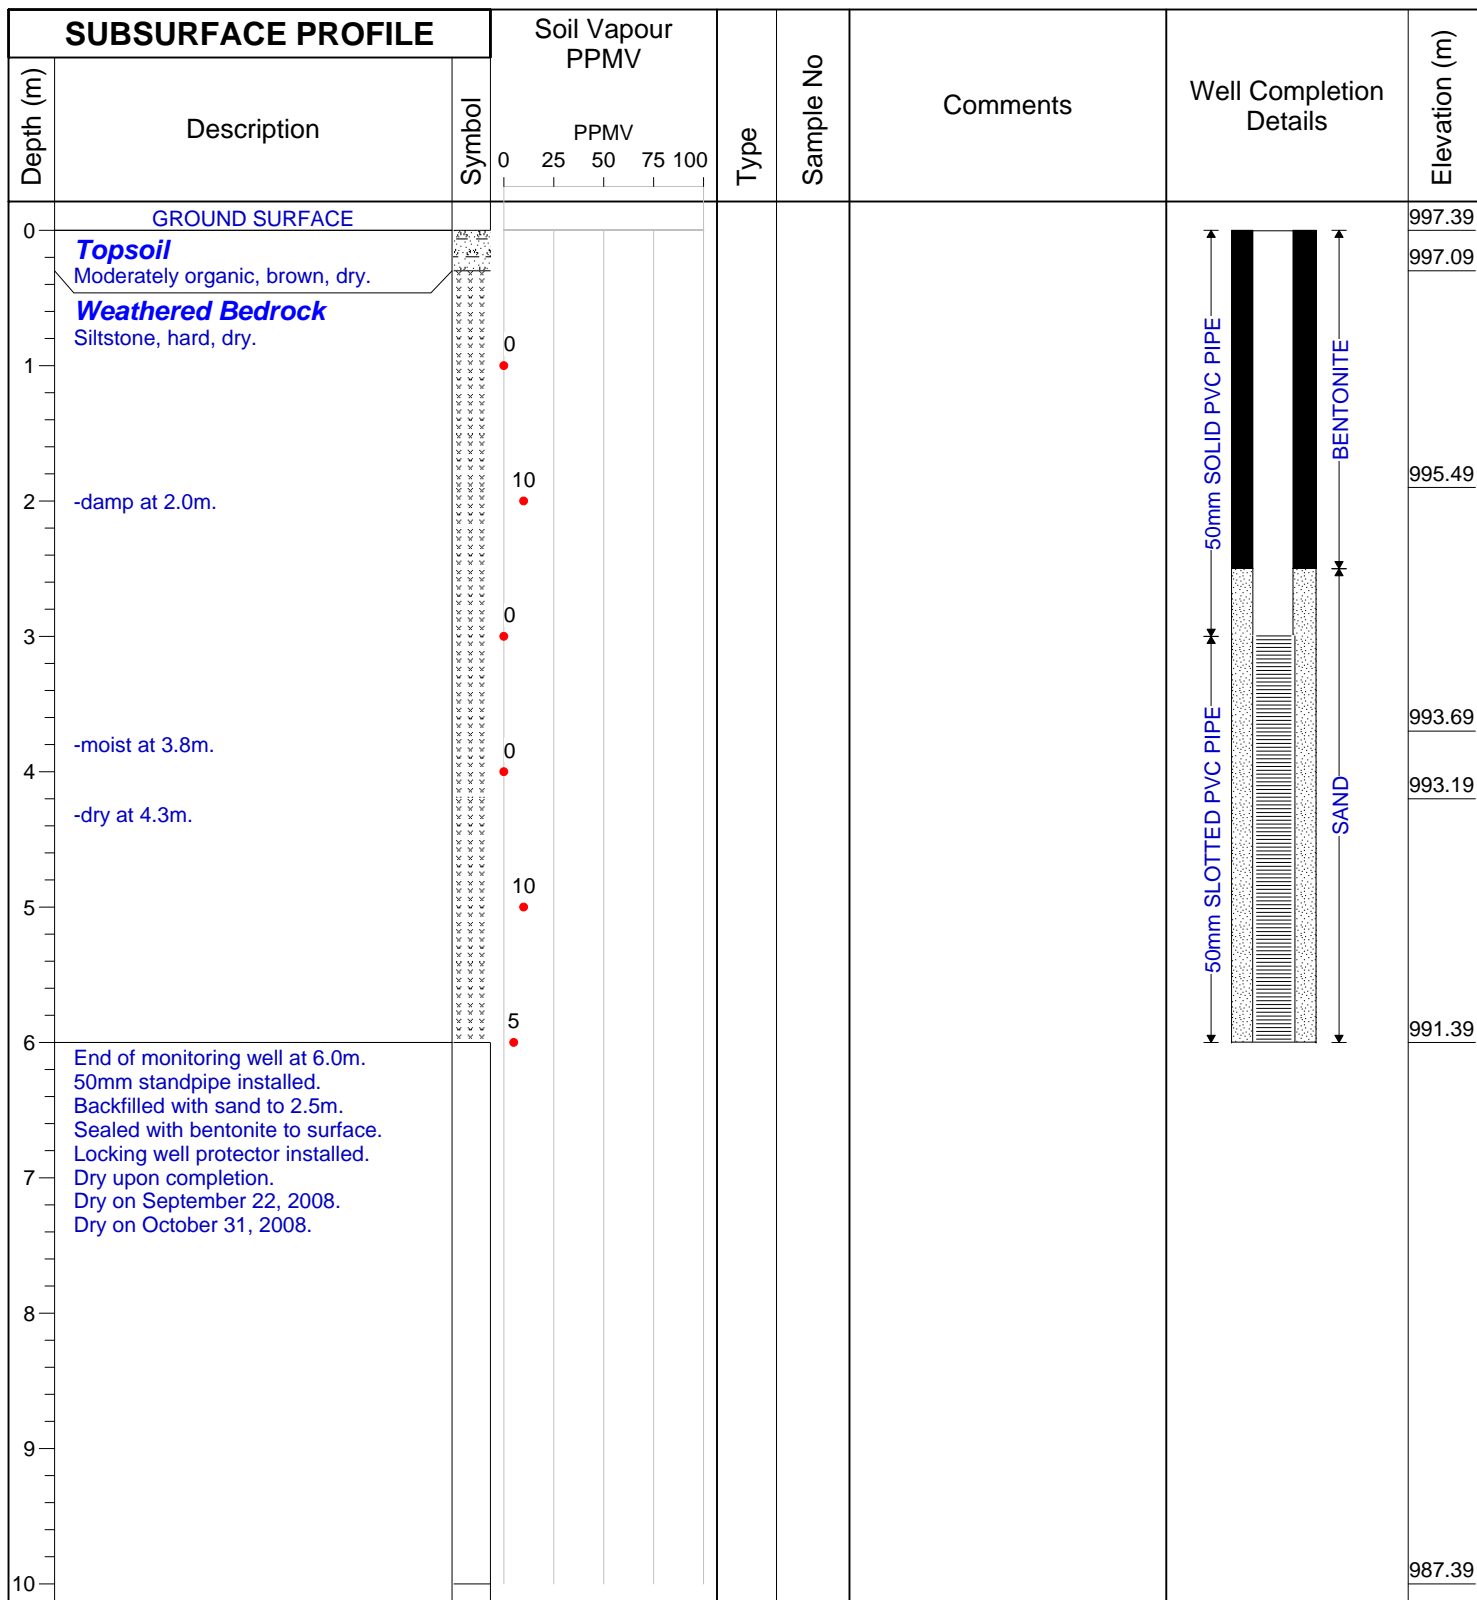
GROUND ELEVATION: 997.390m  
 NORTHING: 5805416.758  
 EASTING: 697785.795

LOGGED BY: PA  
 CONTRACTOR: All Services Drilling Inc.  
 RIG/METHOD: Truck Mounted Auger / Solid Stem Auger  
 DATE: September 12, 2008
