**Re: Geotechnical Investigation
 Proposed Highland Park Subdivision
 Lot 2, Block 1, Plan 0620435
 Part of NE 17 – 39 – 1 – W5M
 Near Sylvan Lake, Alberta**

REPORT NO: 2461 - 412

**GEOTECHNICAL INVESTIGATION
PROPOSED HIGHLAND PARK SUBDIVISION
LOT 2, BLOCK 1, PLAN 0620435
PART OF NE 17 – 39 – 1 – W5M
NEAR SYLVAN LAKE, ALBERTA**

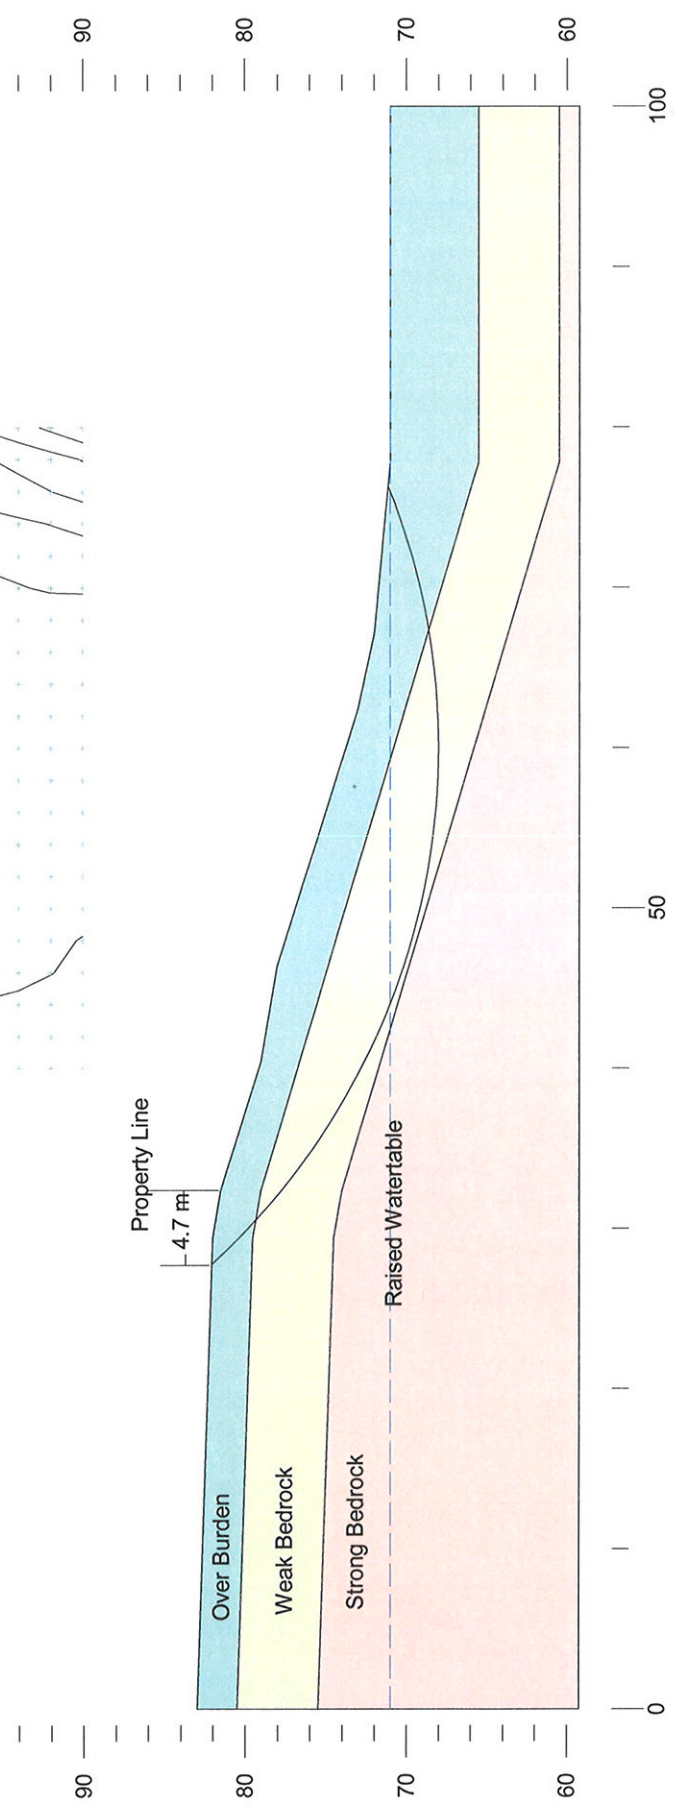
Figure A1

J. R. Paine & Associates Ltd. - Edmonton, AB
 2461 - 412
 Highland Park
 April 24, 2009
 Profile A
 Translational Slip Surface

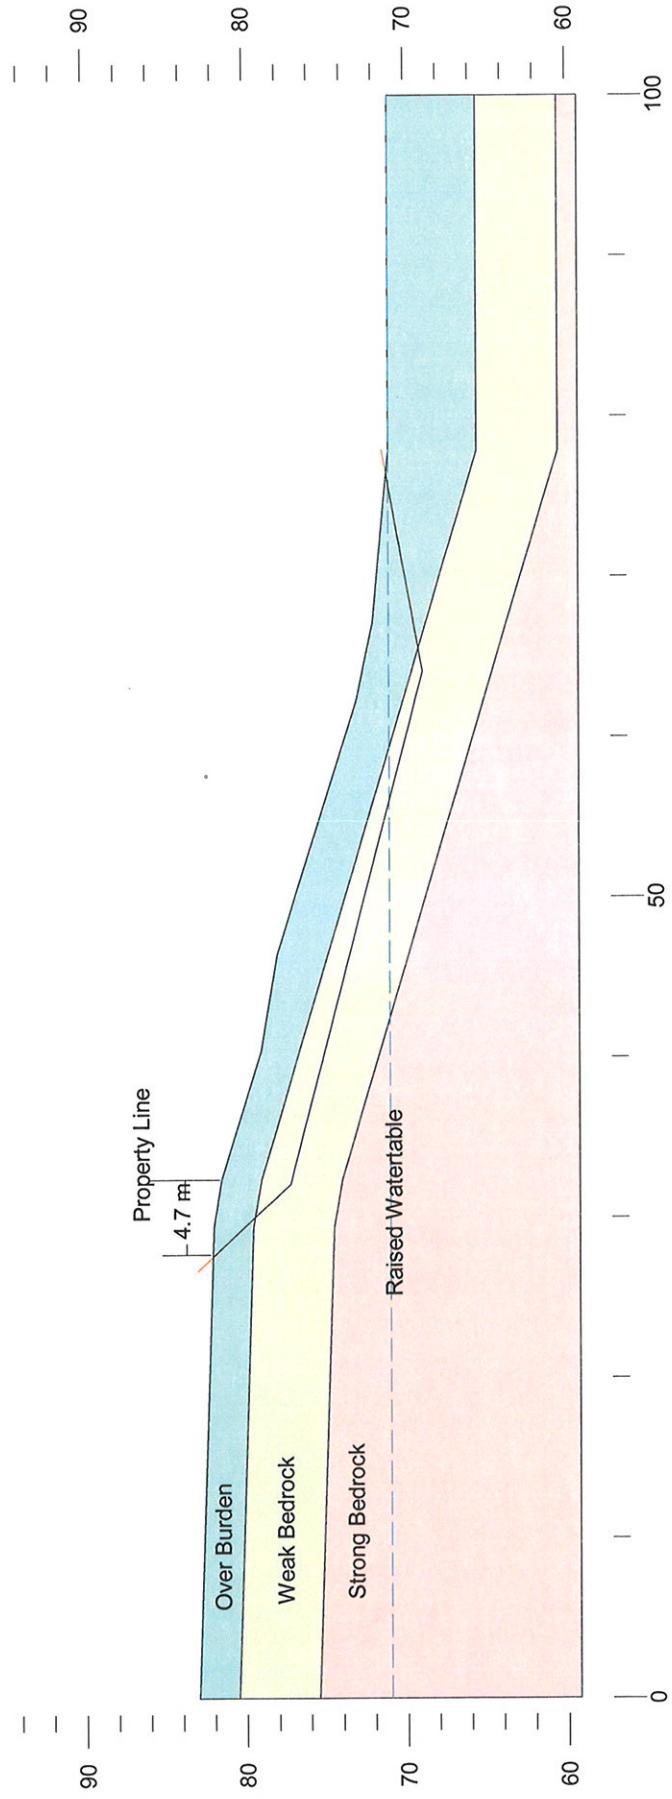
Figure A2

J. R. Paine & Associates Ltd. - Edmonton, AB.
 2461 - 412
 Highland Park
 April 24, 2009
 Profile B
 Circular Slip Surface
